CCD THICKENER EXIT CONES

CASE HISTORY

SUMMARY : Imatech ARC MX1 was specified to replace the failed rubber lining and protect the exit cones.

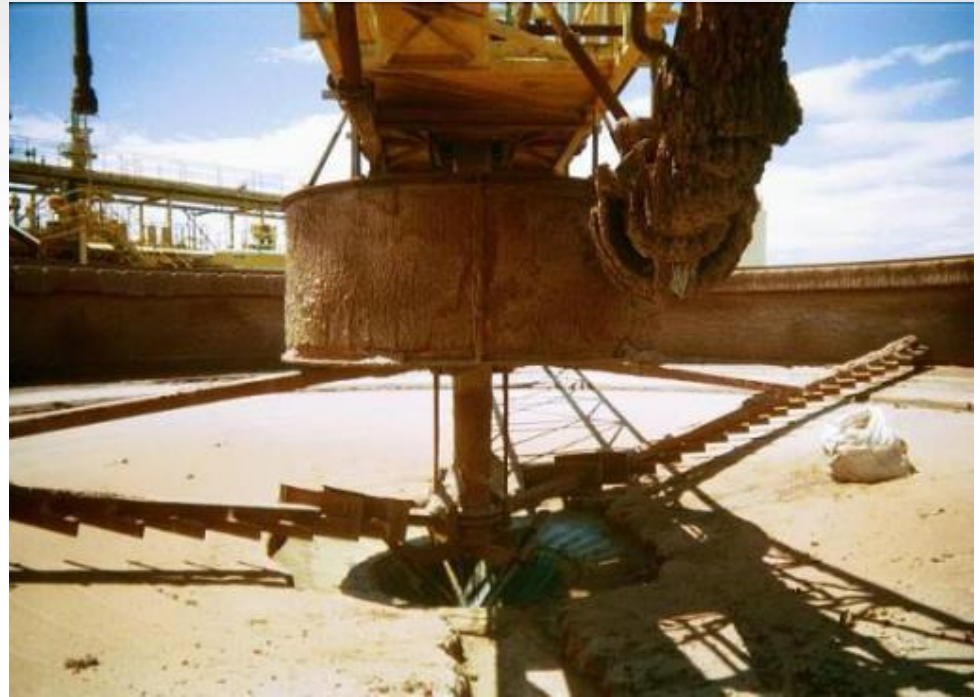
With constant agitation and abrasion the rubber lining proved ineffective with lifting, delamination and underfilm corrosion occurring.
