CENTRIFUGE TILES

CASE HISTORY

SUMMARY CENTRIFUGE TILES

SUMMARY : Impact resistant trowel-on grout.

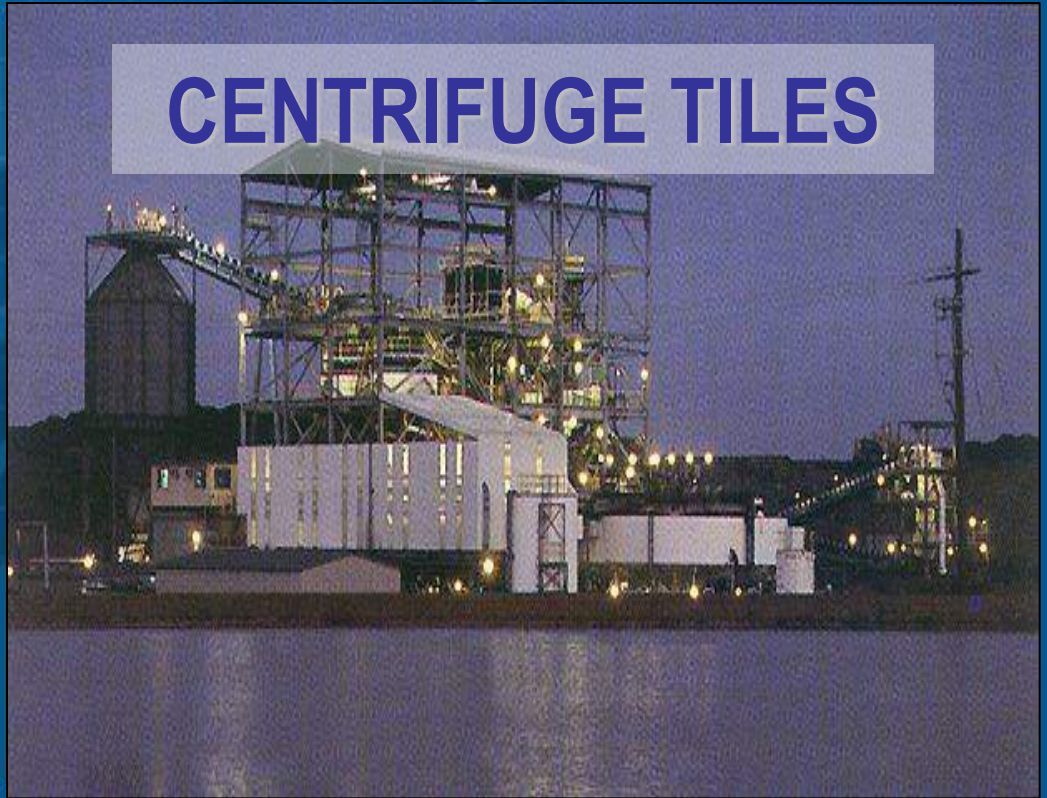
- The tiles in the centrifuge were in a bad condition.
- The inside of the centrifuge had to be re-coated every 2 weeks.
- Consequently, the customer had to change the wear plates more often as well.

- The area was prepared using a grinding disc and a needle gun.
- IBX1 was then applied for the 1st time.

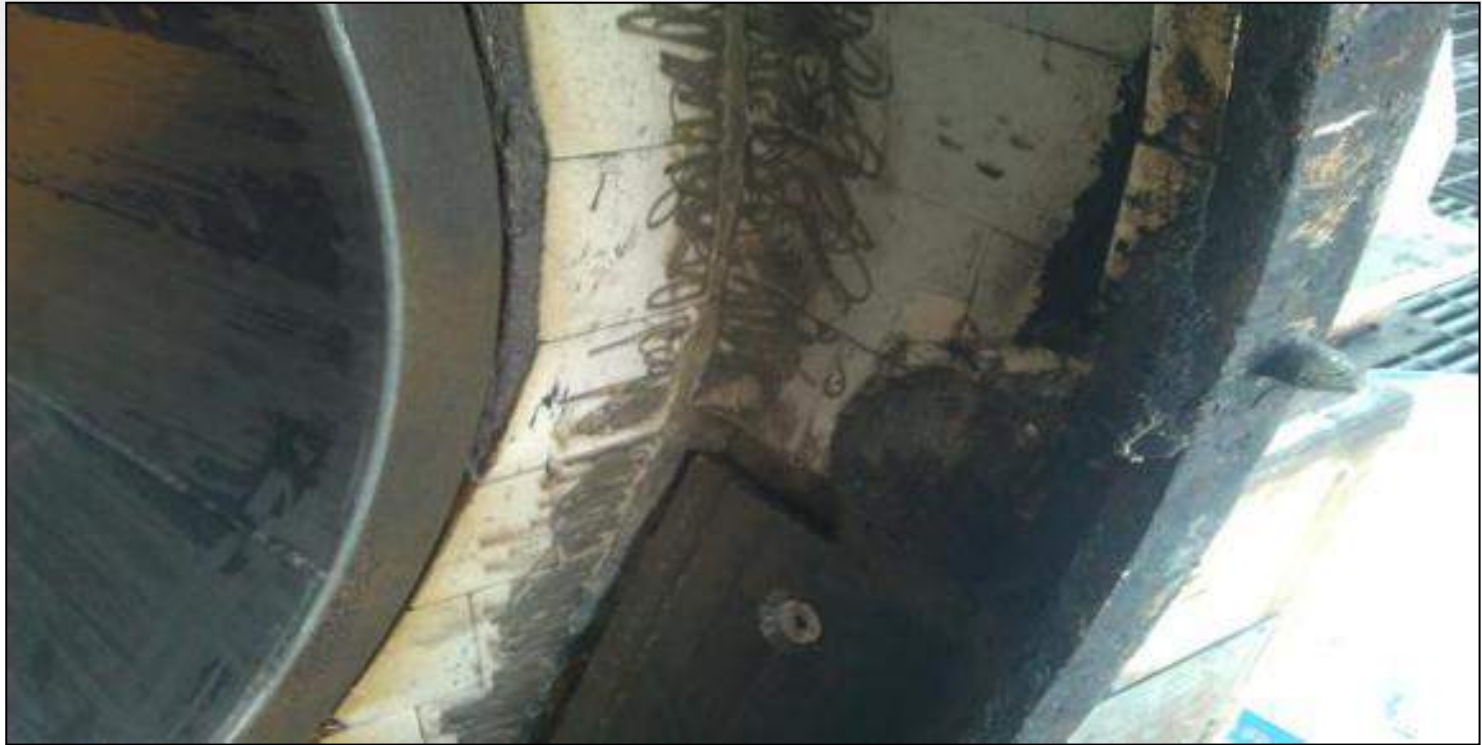
Preparation of affected area.

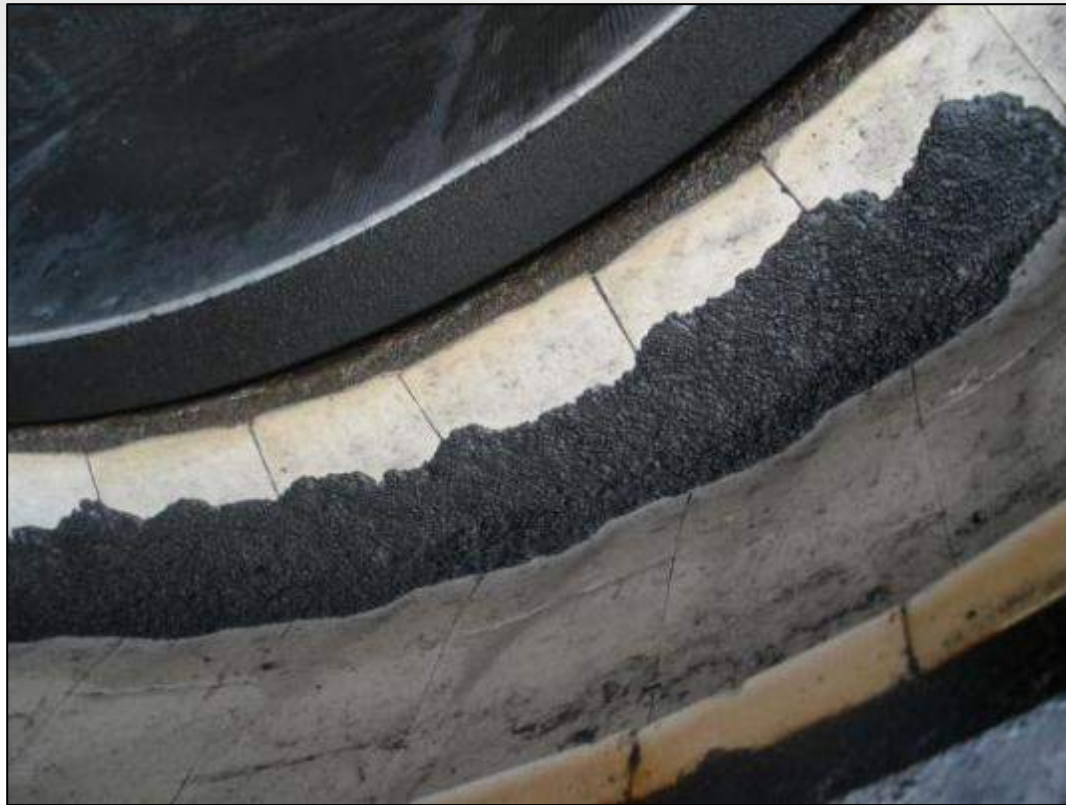
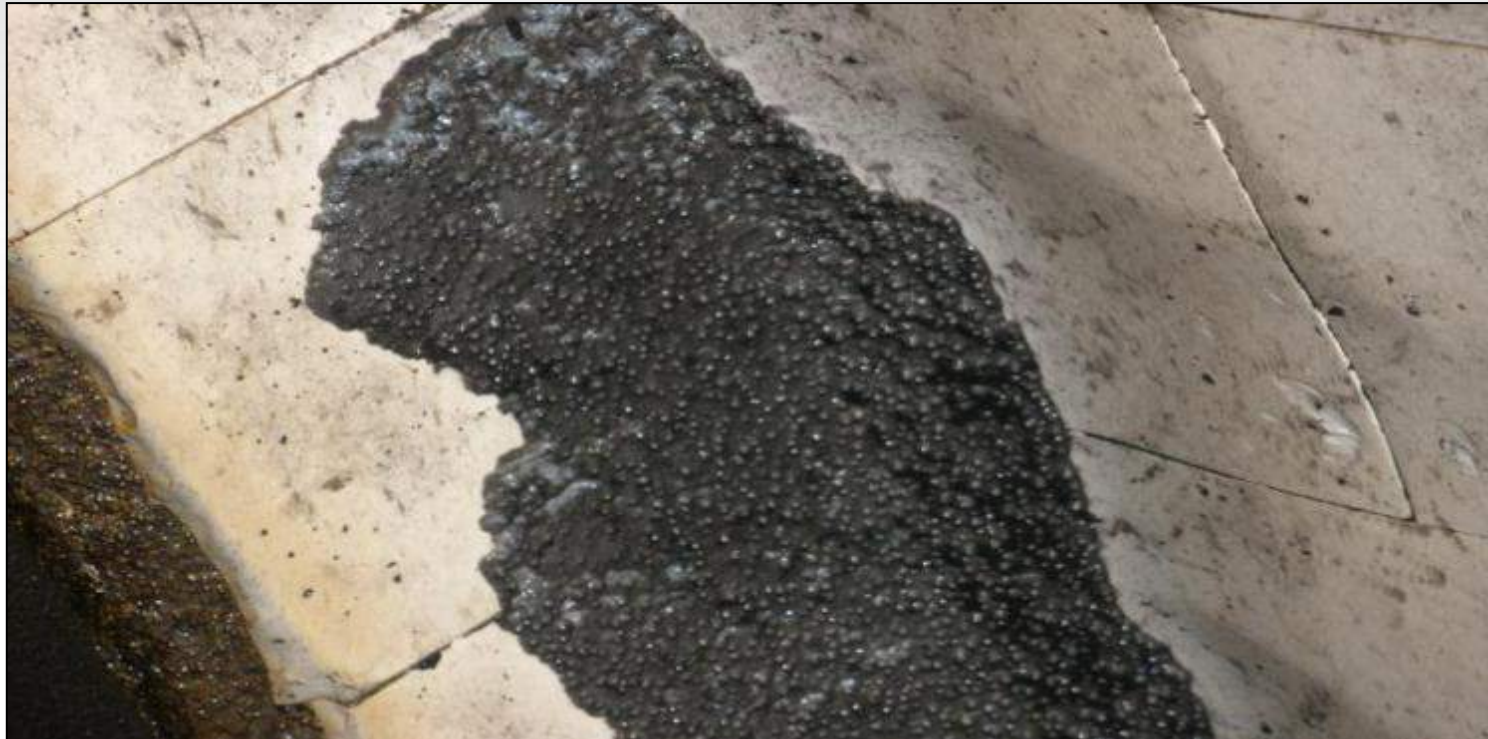
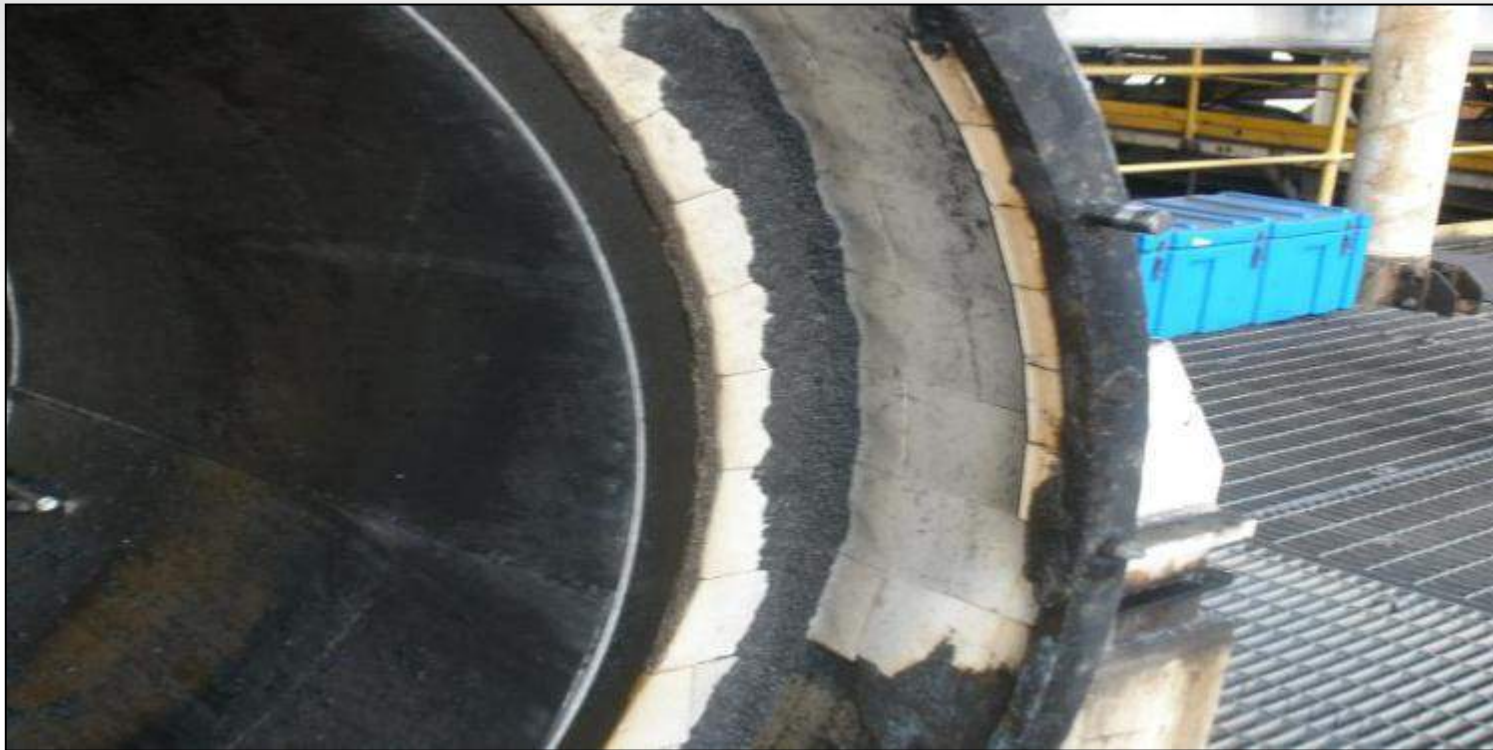
- IBX1 application still looks new even after a month with only minimal wear.
- The current coating is predicted to last 3 months however, it could be longer.
