# COAL SCREEN UNDERPAN

## CASE HISTORY

**SUMMARY** : Removal of failed polyurethane and protected with ARC ceramic composite coating.

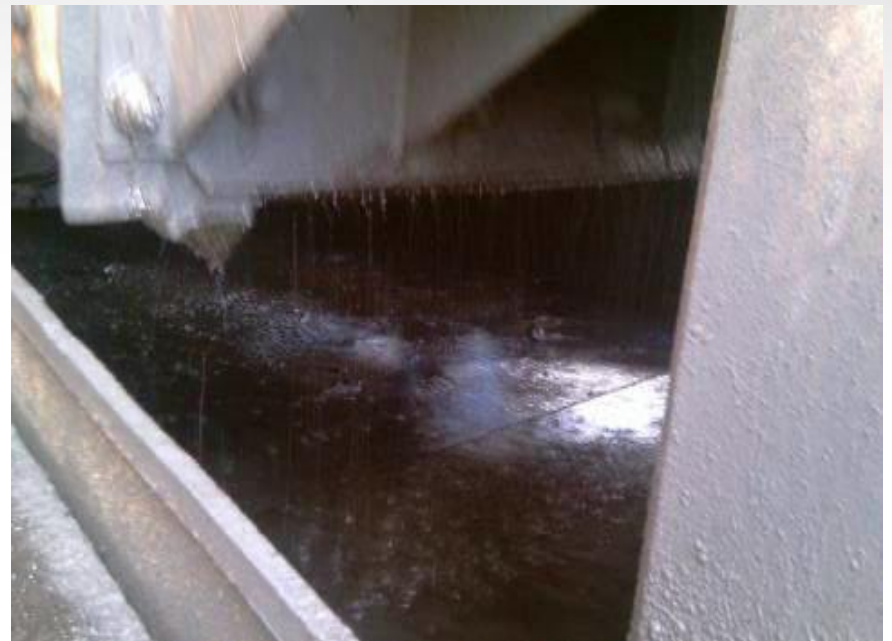
- The underpan was originally coated with polyurethane. The polyurethane was failing due to inter-coat adhesion issues and was coming off in sheets.
- This was causing pump blockages and leaving the under-pan susceptible to premature corrosion issues.

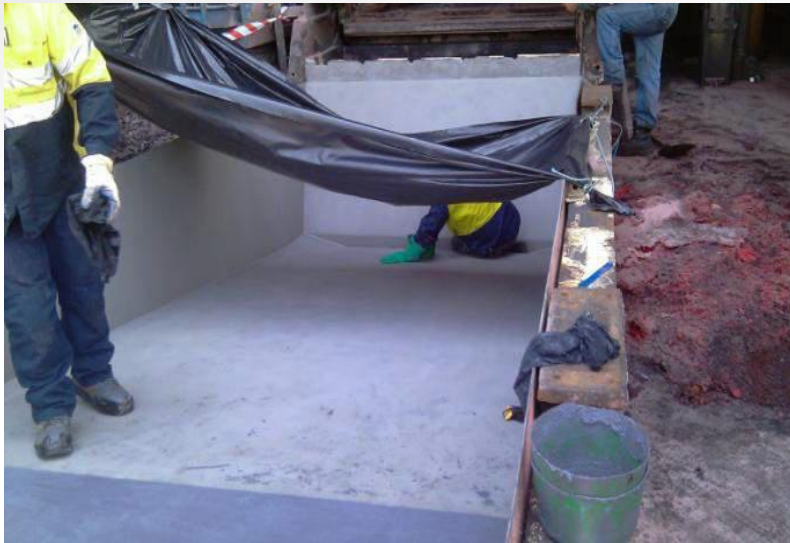
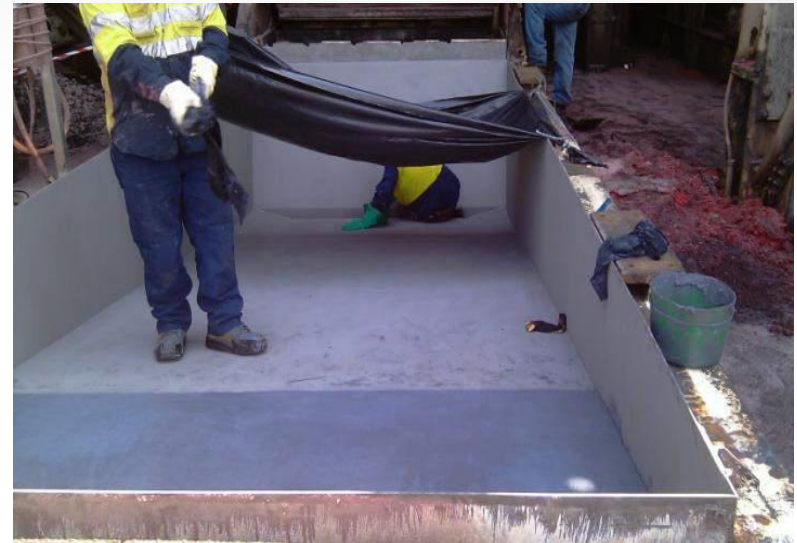
# SOLUTION

- Imatech removed the polyurethane using ultra high water pressure blasting.
- The underpan was then abrasive blasted to our specifications.

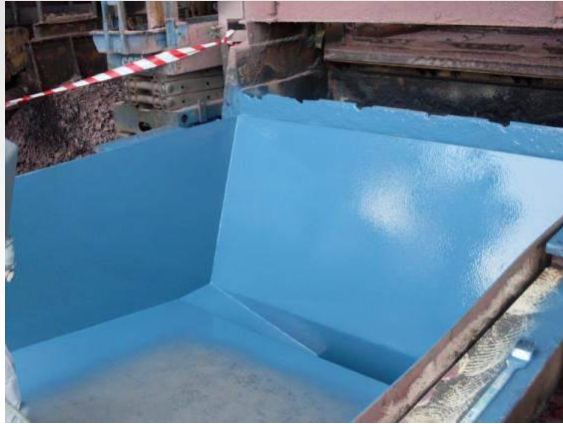
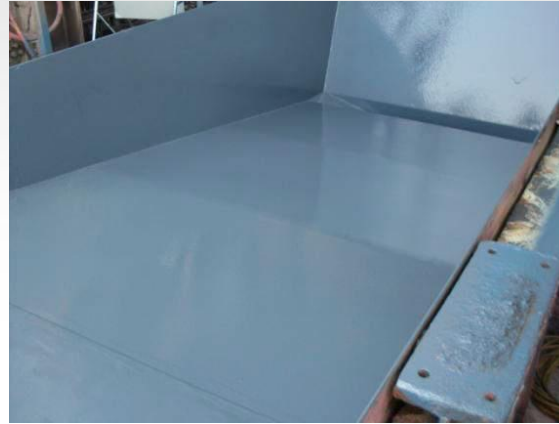
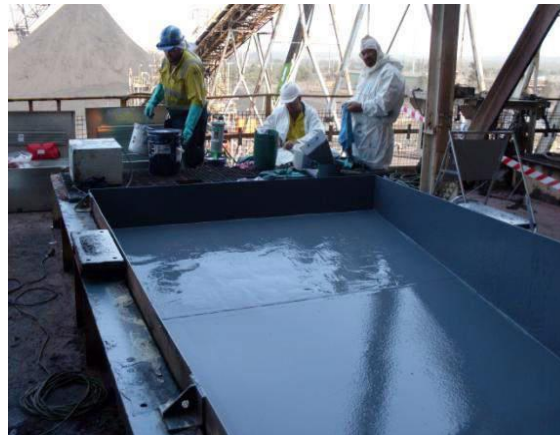
The following photos are from an inspection six months later. It can be observed that the top coat of SD4i is untouched and the BX2 coating is intact.

We then applied two coatings of our ARC SD4i ceramic reinforced composite coating, at a thickness of 400 microns each; giving a total thickness of 800 microns.

The first coat was done in blue and the second coat in grey, assisting in future wear indication.
