REJECT SCREEN DISCHARGE CHUTE

CASE HISTORY

SUMMARY : Tile disbondment and heavy abrasion lead to a large hole in a chute needing frequent patch ups. ARC BX2 was applied outperforming all previously trialed products.

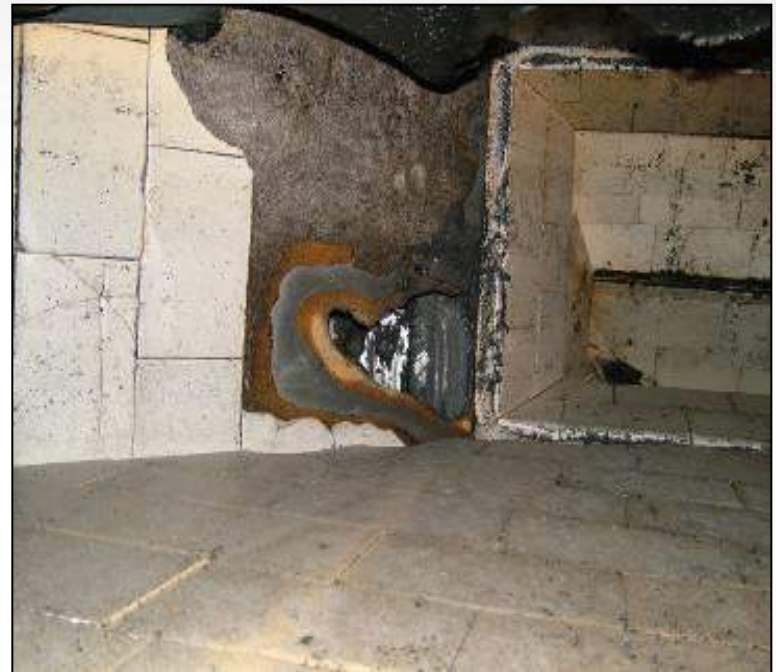
- Tiles were smashed and dis-bonded in the chute due to high localised impact and wear.
- Previous wear resist patching needed repairs every 4 to 6 weeks.
- Confined space entry and difficult access lead to expensive labour costs.

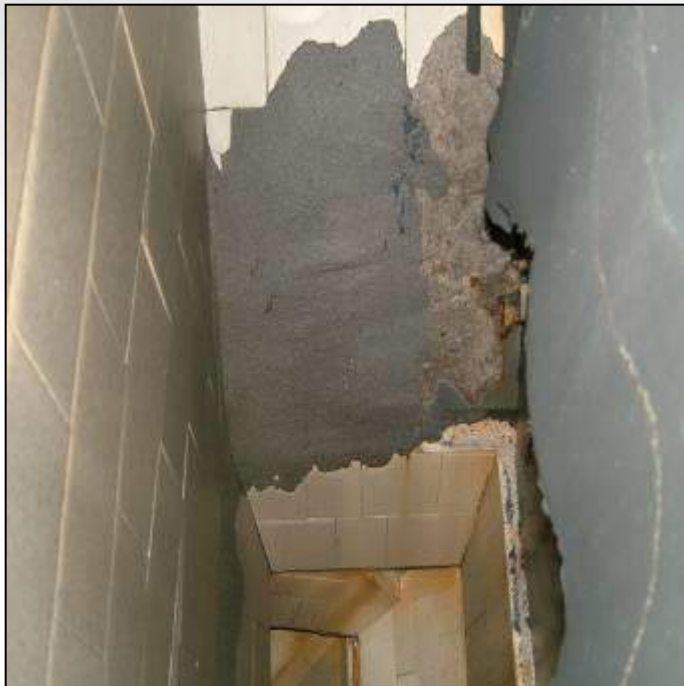
- This photo was taken after a 3 month inspection illustrating no visible signs of wear.
- No down time, No unscheduled shuts.
- No costly repairs.
