SEA WATER CONDENSER

CASE HISTORY

SUMMARY

- INDUSTRY** : Liquid Ammonia Fertiliser Plant
- PRODUCT** : ARC 855 HT, ARC 858 Tubes & ARC BX2
- EQUIPMENT** : Sea water condenser
- LOCATION** : Karratha, WA, Australia
- SUMMARY** : Severe sea water corrosion had caused a “blow-out” on the tube face of the electrical power plant condenser; causing unplanned stoppage and maintenance.
- ROI** : The damage was repaired with specialised welding and sealed with ARC products to ensure there would be no problems for at least 5 years.

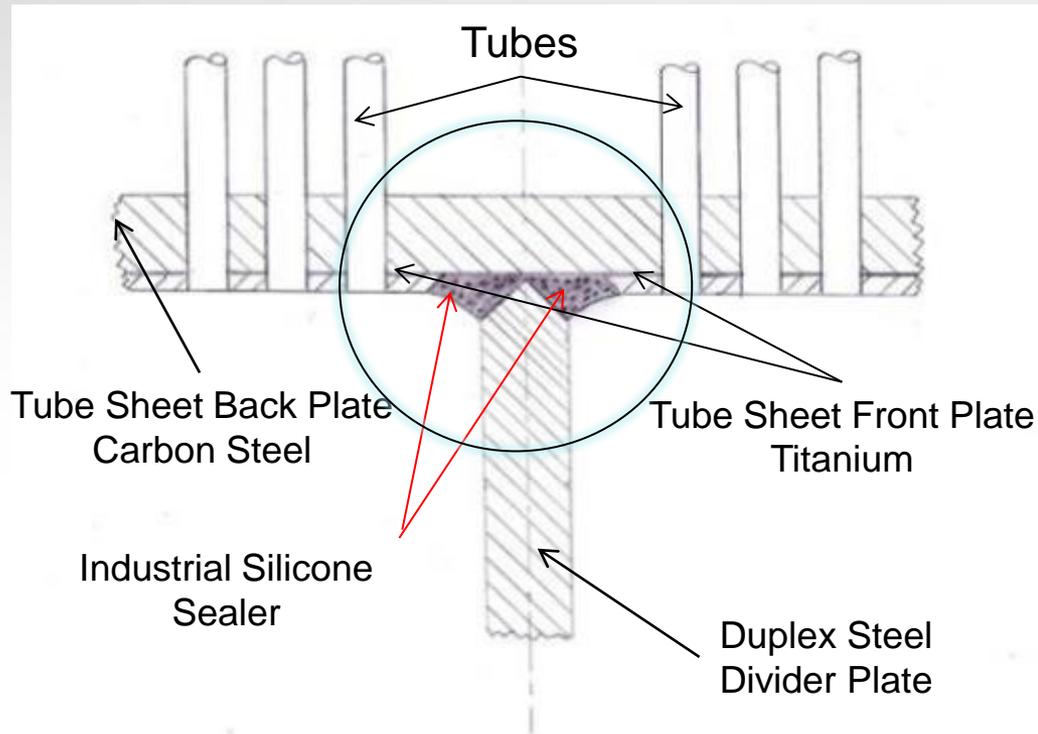
Original Design

The condenser was fabricated from 3 different metals:

1. The shell and divider plates were all made from duplex steel.
2. The tube sheet had a carbon steel backing plate.
3. The front plate of the tube sheet was made from titanium.

The part where the 3 metals came together could not be welded and it was decided that the corners would be sealed off with an industrial silicone.

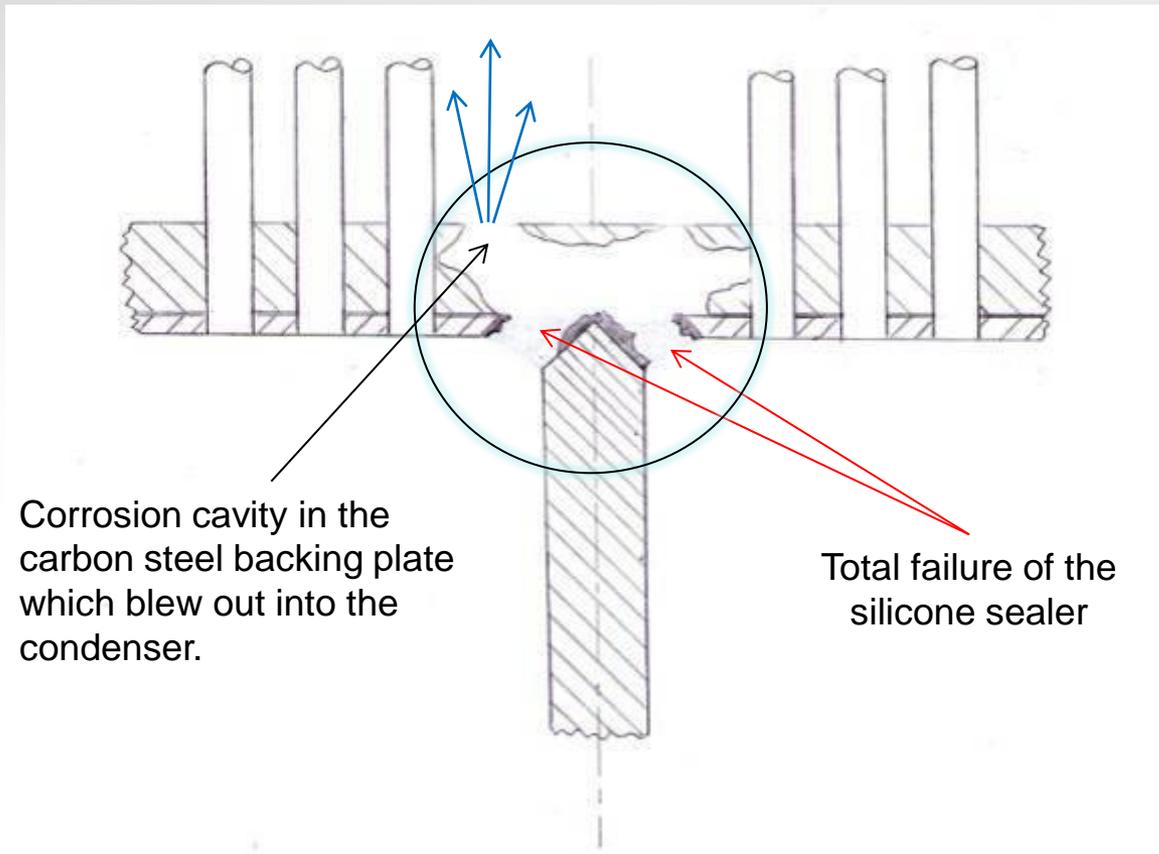
Tube Sheet Failure

Corrosion cavity in the carbon steel backing plate which blew out into the condenser.

Total failure of the silicone sealer

Due to the total failure of the silicone sealer, the carbon steel backing plate severely corroded from the sea water, to the extent that it 'blew out' into the body of the condenser; causing total failure and unplanned shut down.

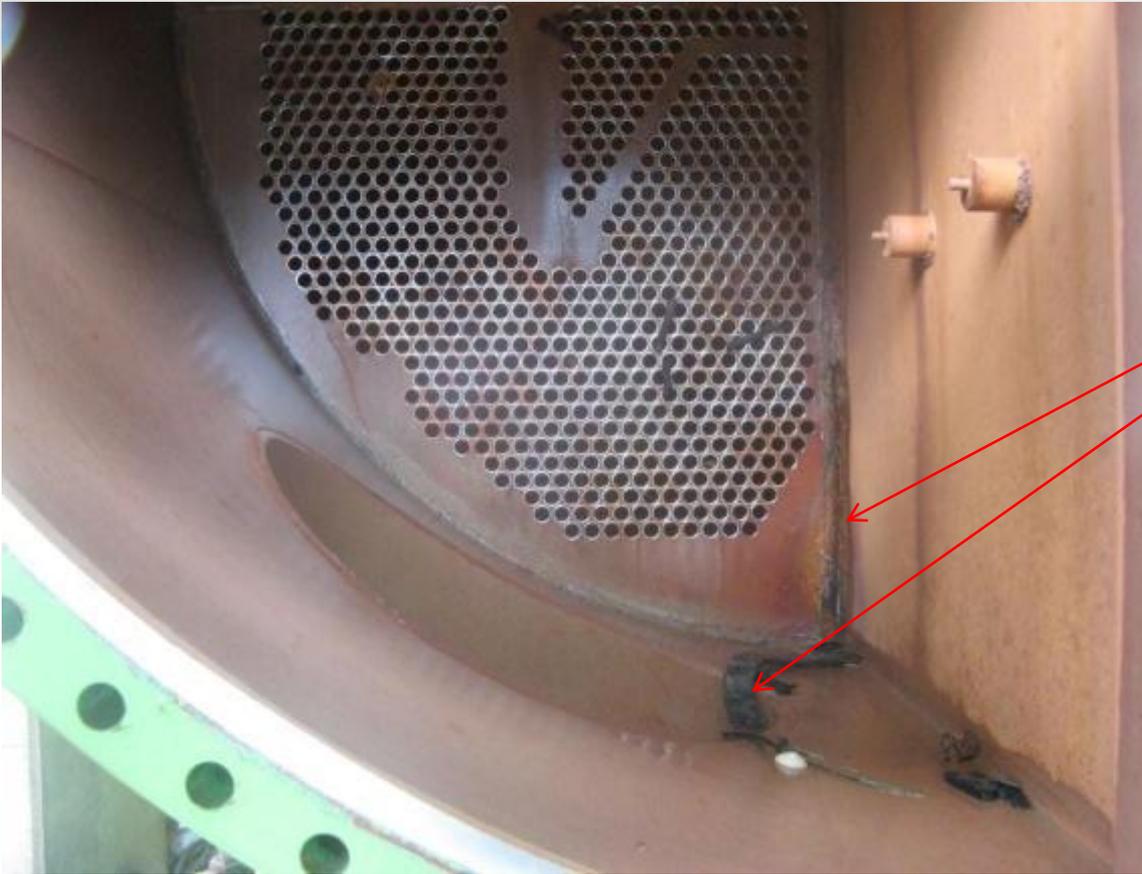
The water box showed pieces of silicone still evident after delaminating from the corners of the tube sheet.

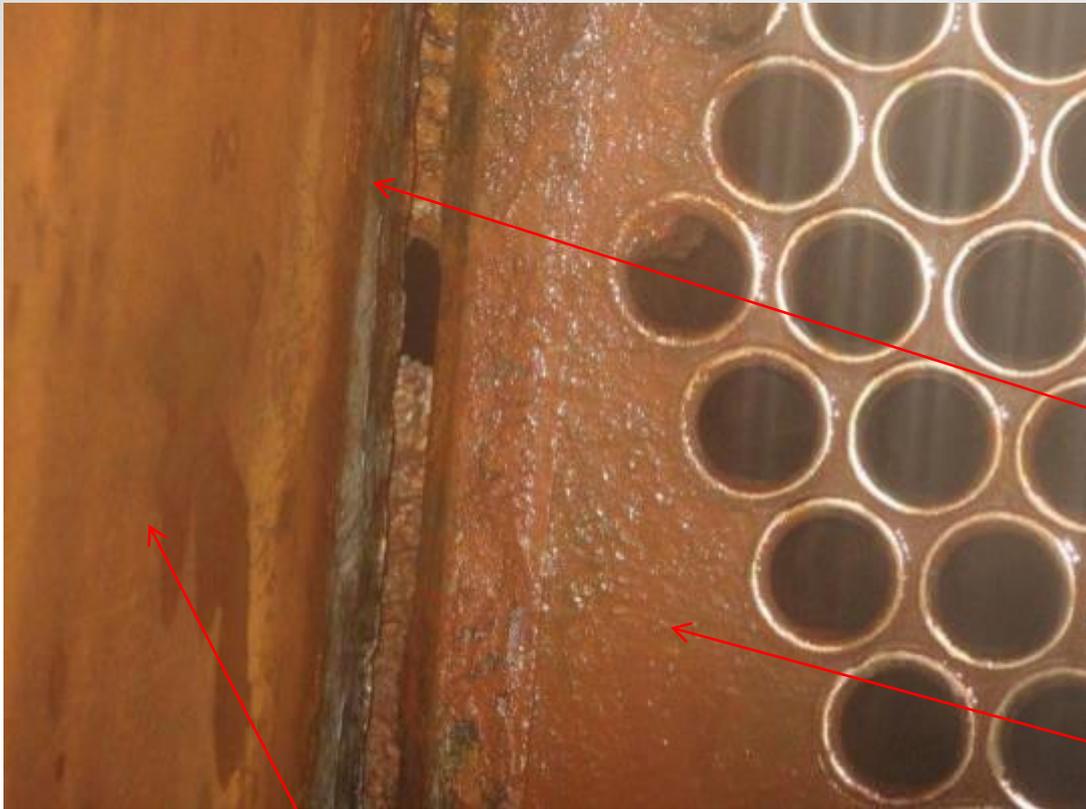
- Blow-out of the carbon steel backing plate

Absolutely no silicone was found in this chamber where the carbon steel backing plate had completely corroded through.

Titanium tube face

Duplex steel divider plate

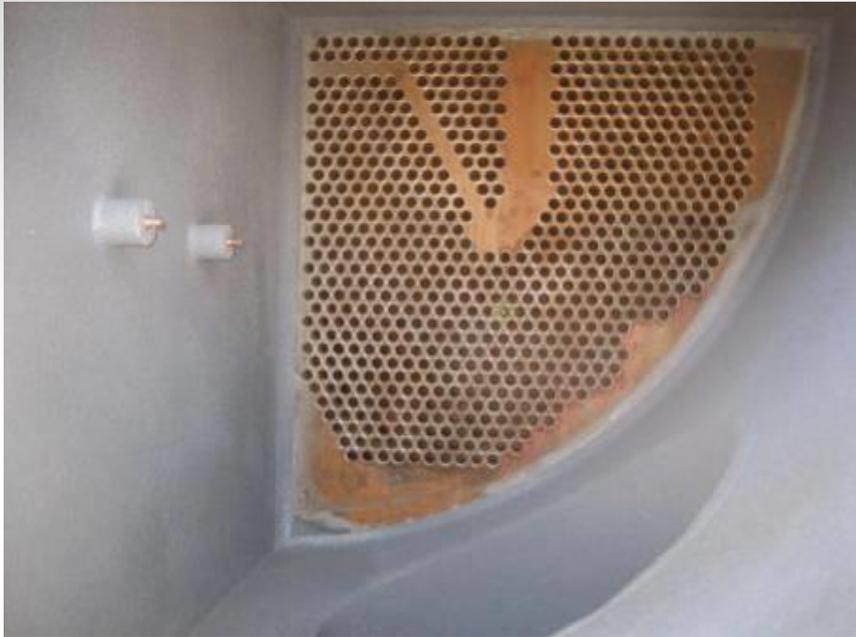
The titanium tube face had shown no corrosion, so no coating was necessary.

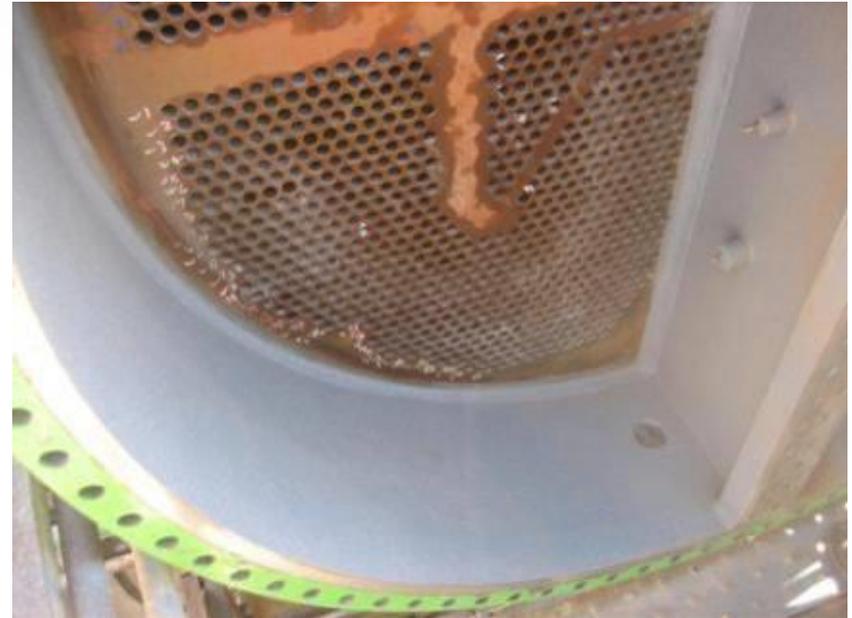
The Finished Product

Finally, 2 x 350 micron coats of ARC 855 HT were 'sprayed on' to ensure total corrosion protection from the sea water, which operated in temperatures up to 120⁰ C.

Finally, the end caps were also coated with 2 coats of ARC 855 HT. A four year warranty was given to insure them against product and application failure.
