Corrosion Repair on Outer Tank Base with ARC S1

CASE HISTORY

INDUSTRY : Refinery

EQUIPMENT : Storage Tanks

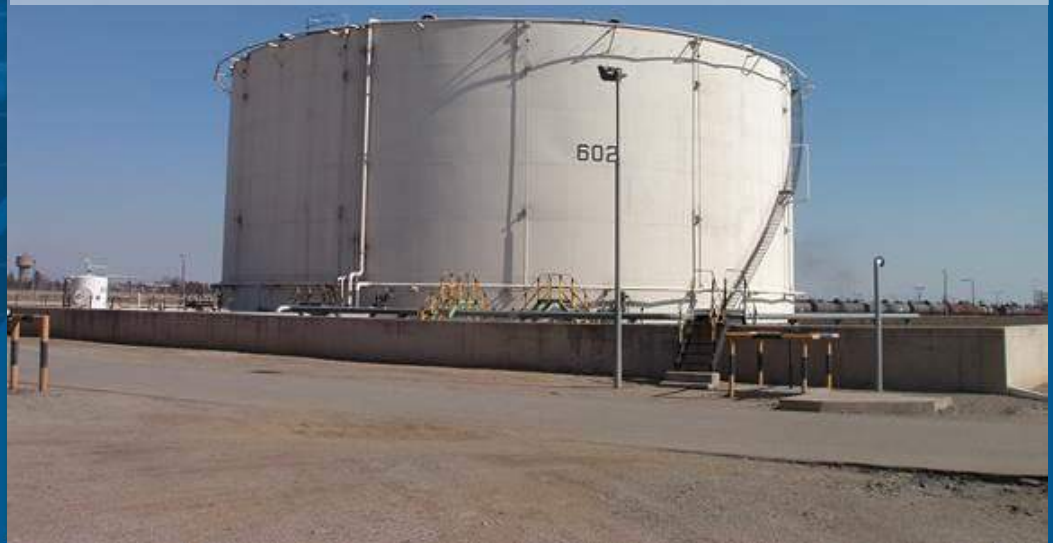
Corrosion of the outer tank bottom, the edges and weld seam. Water collected in this area because the tank pad sloped towards the metal tank.

Remove the bitumen cushion underneath the tank to a depth of 10 to 15 cm (4 to 6 in.) and a height of 4 to 6 cm (1.5 to 2.5 in.). After cleaning and preparing the exposed metal, apply two coats of ARC S1 covering this area including a strip of 30 cm (12 in.) above the bottom and around the tank.

ARC 791 is used to reconstruct the bitumen base and to slope the surface towards the outside of the tank, preventing water from collecting under the tank. Final insertion of rubber gaskets and waterproof silicone sealant prevents any water infiltration.

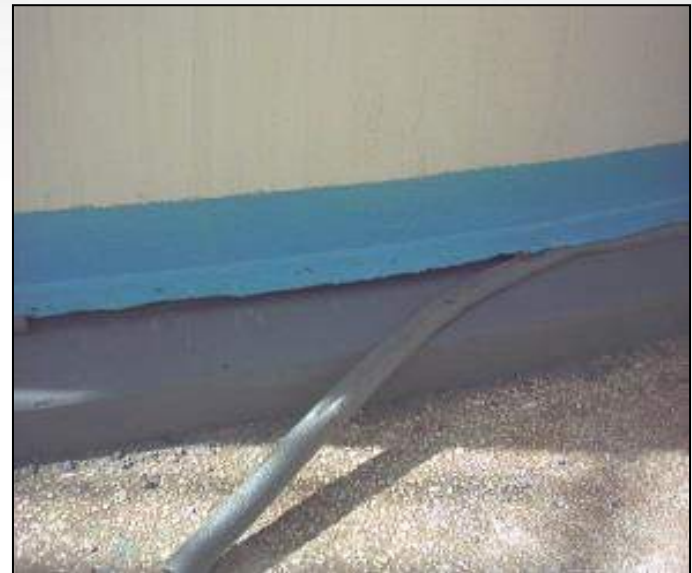
The first 6 tanks were completed in November 2003. To date, the application is still in perfect condition, and the customer has completed the remaining tanks as well.
