COAL SUMPS

CASE HISTORY

PLANT : Coal Washery

LOCATION : Blackwater, QLD

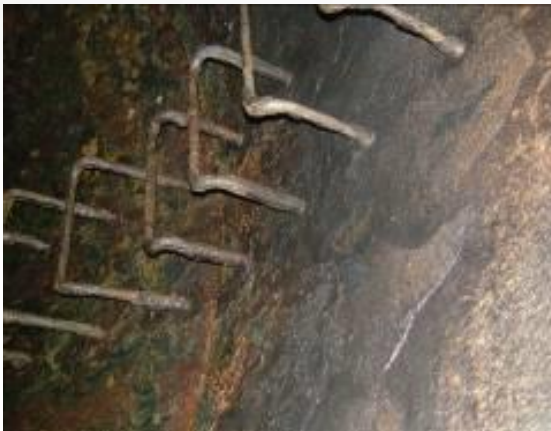
- Client was facing high sump replacement costs due to heavy corrosion.
- Severe pitting and holes in the sump.

1. Condition prior to re-grading

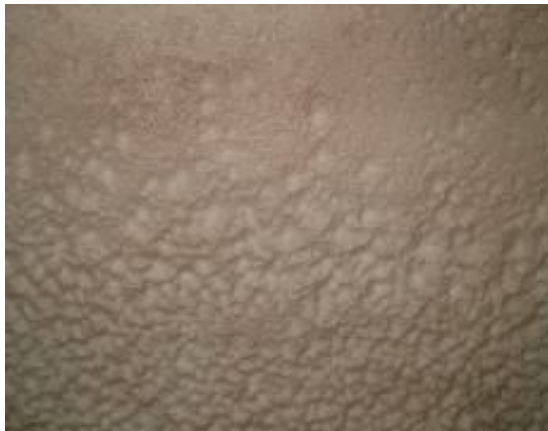
2. Blasted surface

SUMMARY : Internals of de-sliming sumps were heavily pitted and holed out. Imatech water blasted the rust scales and the previous liner with ultra high pressure, then grit basted, regraded and lined the internals of the sumps with a combination of ARC 858, ARC BX2 and ARC S2 for a long term finish.

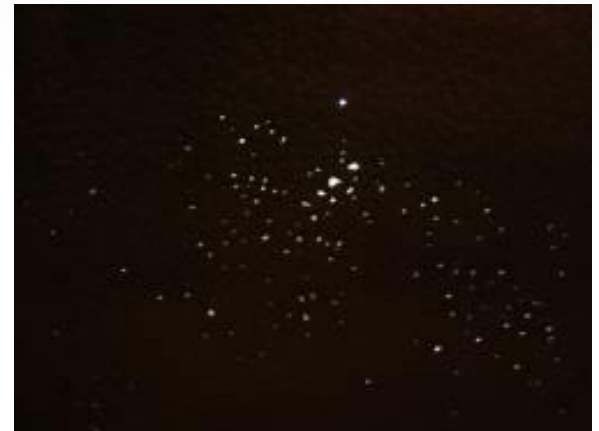
3. Prime coated

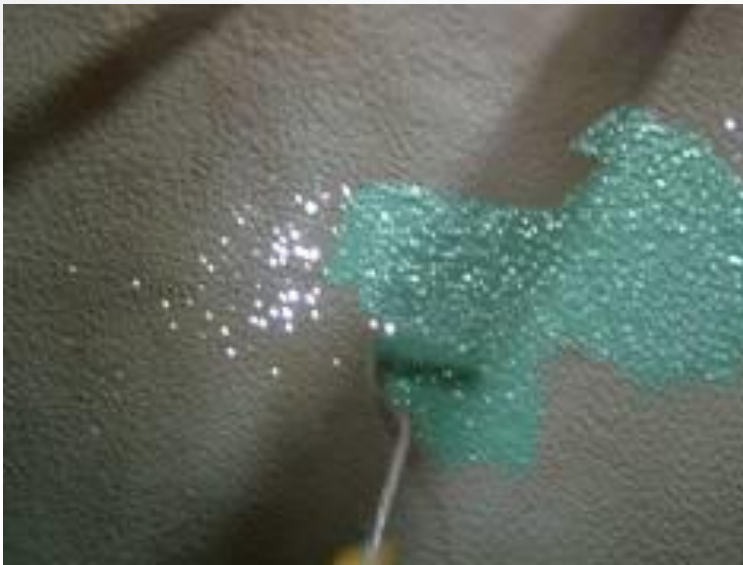
1. Prime coating with ARC S2 Green

Imatech primed holes with ARC S2 then regraded to wall thickness with ARC 858. Remainder of severe pitting was then trowel coated with ARC BX2.

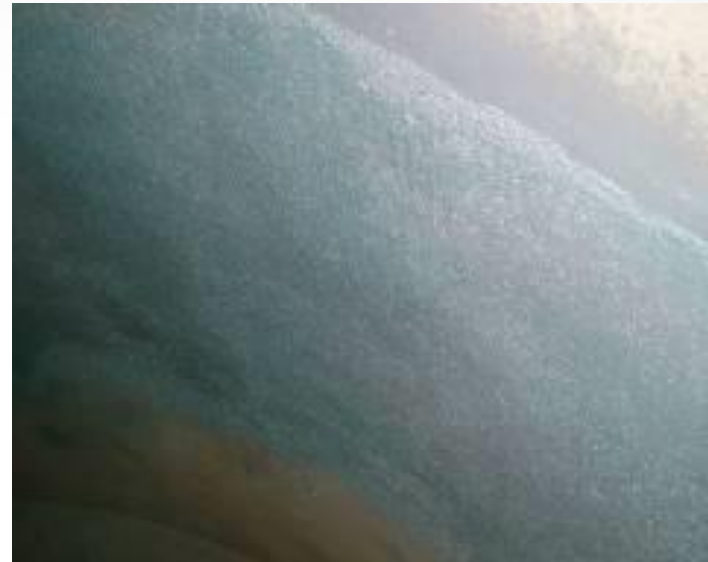
2. Final Coat ARC BX2 Grey

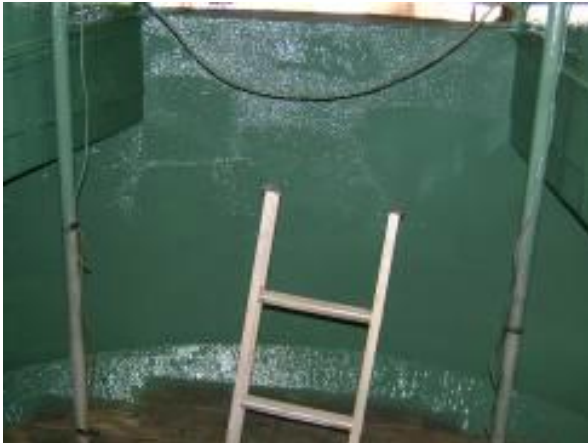
1. Initial prime coat

- All internal surfaces were then coated with two coats of ARC S2 providing a long term abrasion resistant surface.
- The two coat, two colour system allows for easy wear identification when inspecting the coatings.

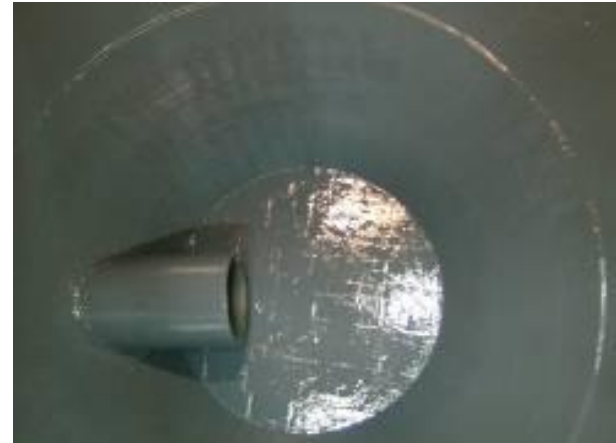
2. Final coat
