CCD THICKENER EXIT CONES

SUMMARY

Industry: Mineral Processing – Nickel

Summary: Chesterton® ARC MX1 was specified to replace the failed rubber lining and protect the exit cones.

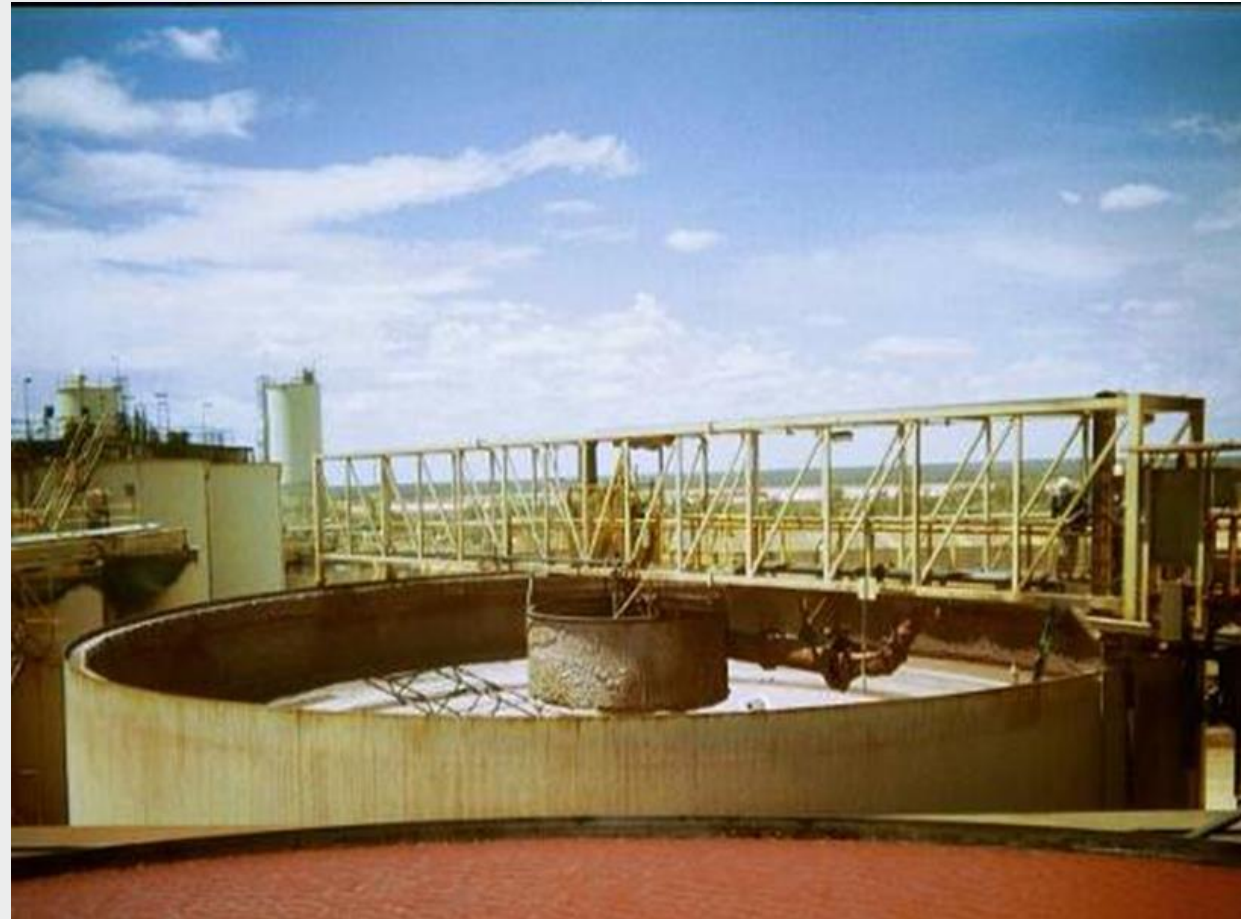
With constant agitation and abrasion the rubber lining proved ineffective with lifting, delamination and underfill corrosion occurring.

Existing failed rubber lining was removed using ultra high pressure water blasting.

Surfaces were then abrasive blasted prior to the application of Chesterton® ARC 855 primer and Chesterton® ARC MX1 trowel on ceramic composite.
