CENTRIFUGE TILES COATING

SUMMARY

Summary: Tiles in the centrifuge were smashed out and required recoating and changeouts of wear plates every two weeks. Impact resistant trowel-on grout Chesterton® ARC IBX1 was then applied, predicted to last 3+ months.

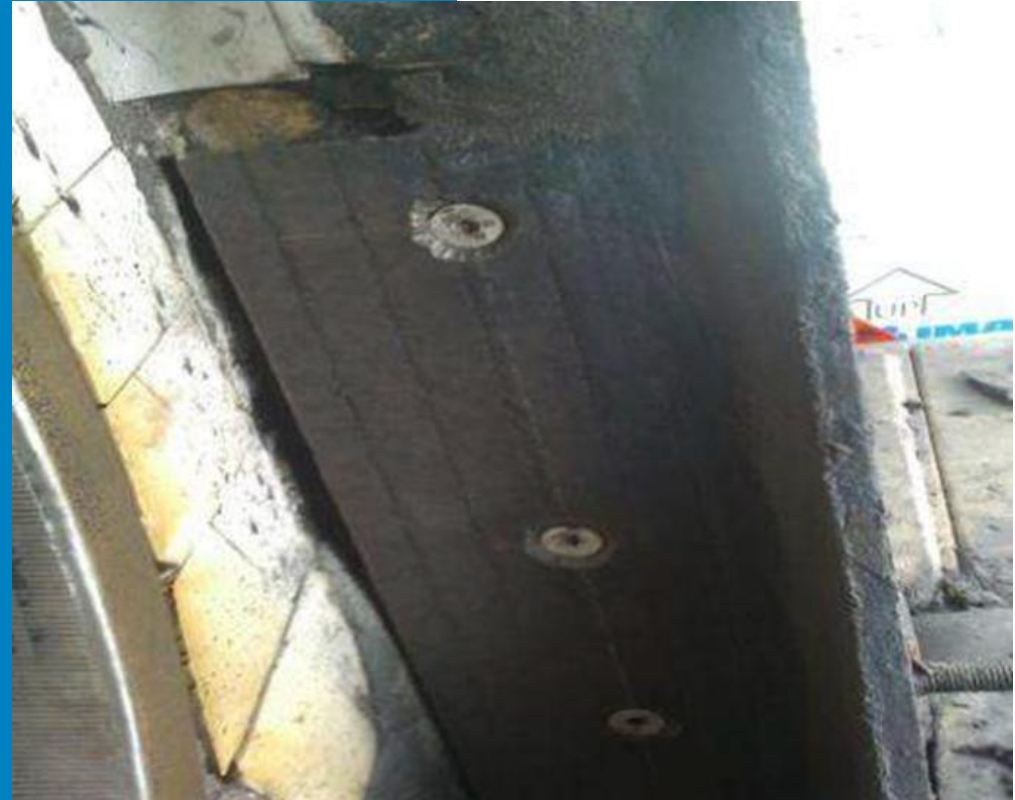
- The tiles in the centrifuge were getting smashed due to high velocity coal.
- This meant that the inside of the centrifuge had to be re-coated every two weeks.
- Consequently, the customer had to change the dubplate more often as well.

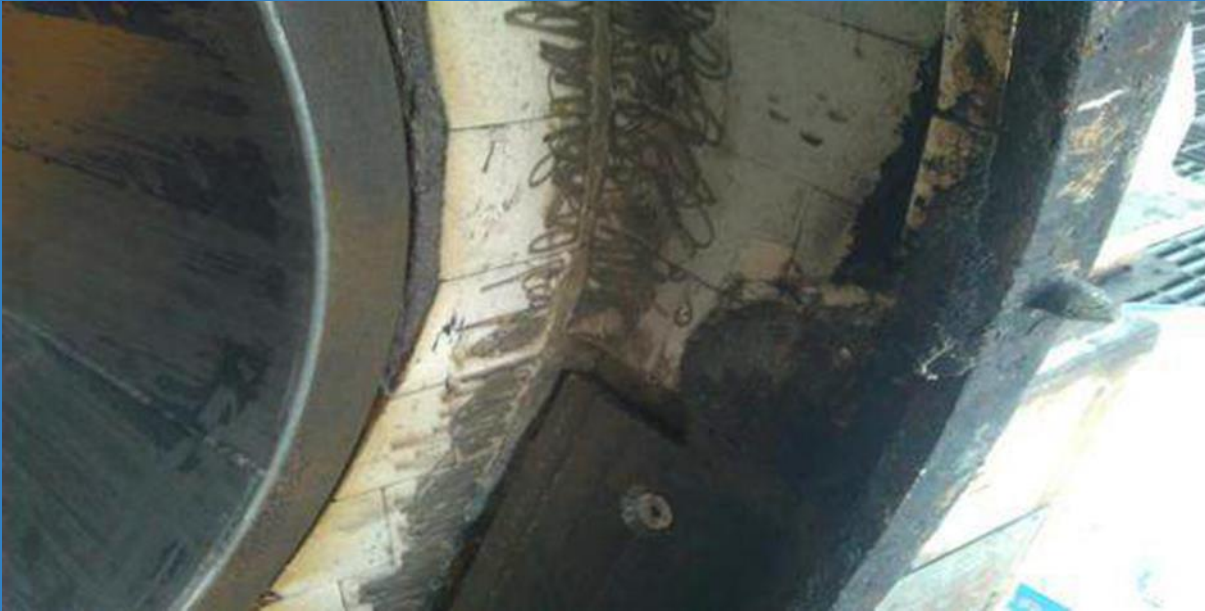
The area was prepared using a grinding disc and a needle gun.

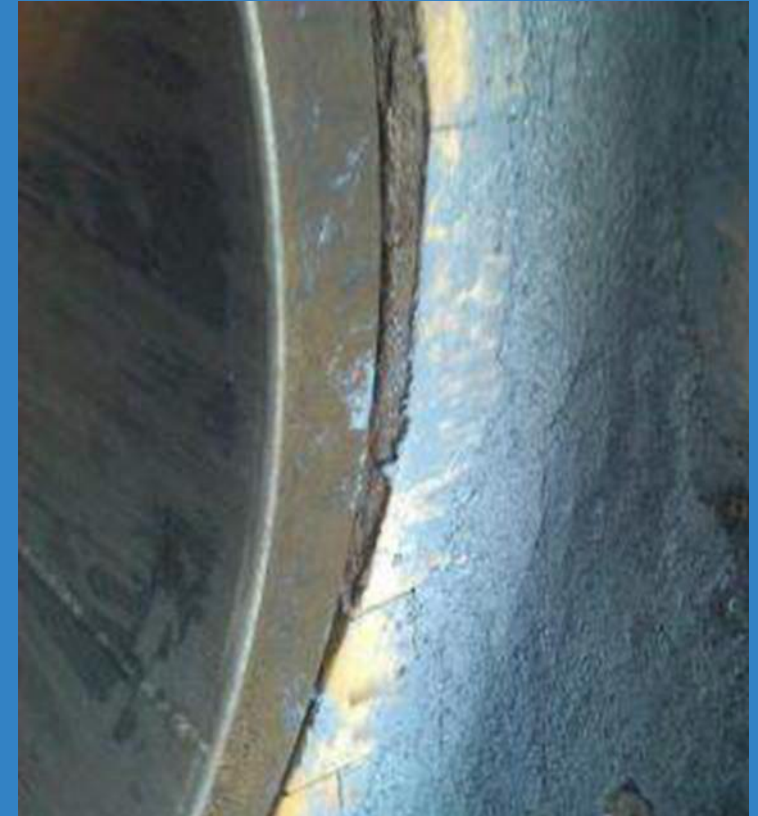
Chesterton® IBX1 was applied to the affected area.

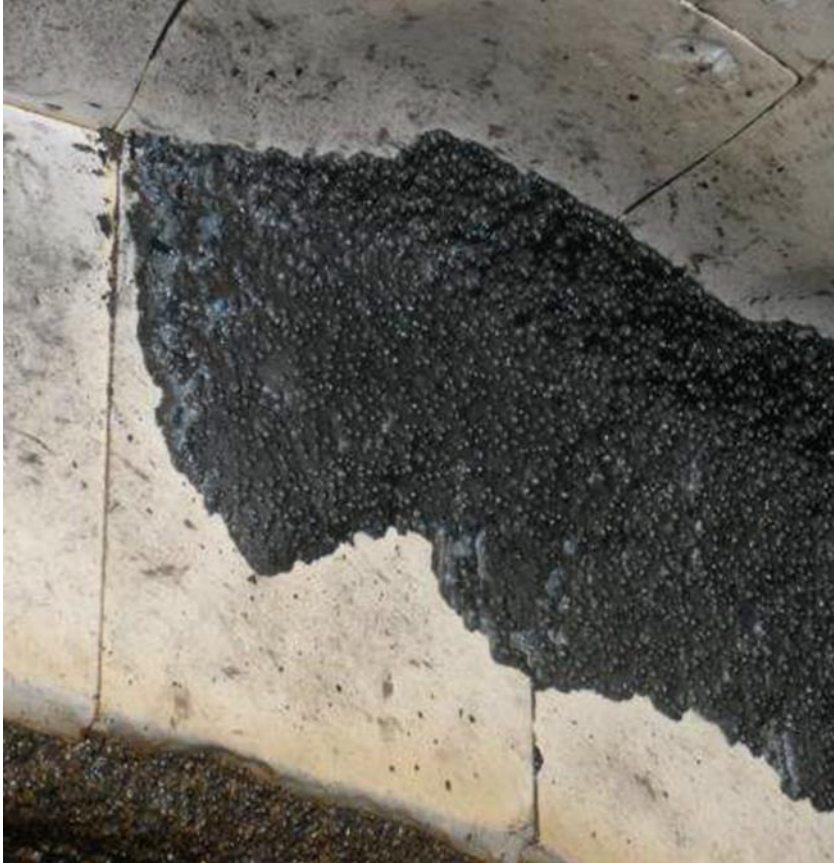
Chesterton® IBX1 application shows minimal wear even after a month.

The current coating is predicted to last 3+ months.
