COAL SCREEN UNDERPAN

SUMMARY

Plant: Coal Screen Underpan

Summary: Removal of failed polyurethane and protected with Chesterton® ARC ceramic composite coating.

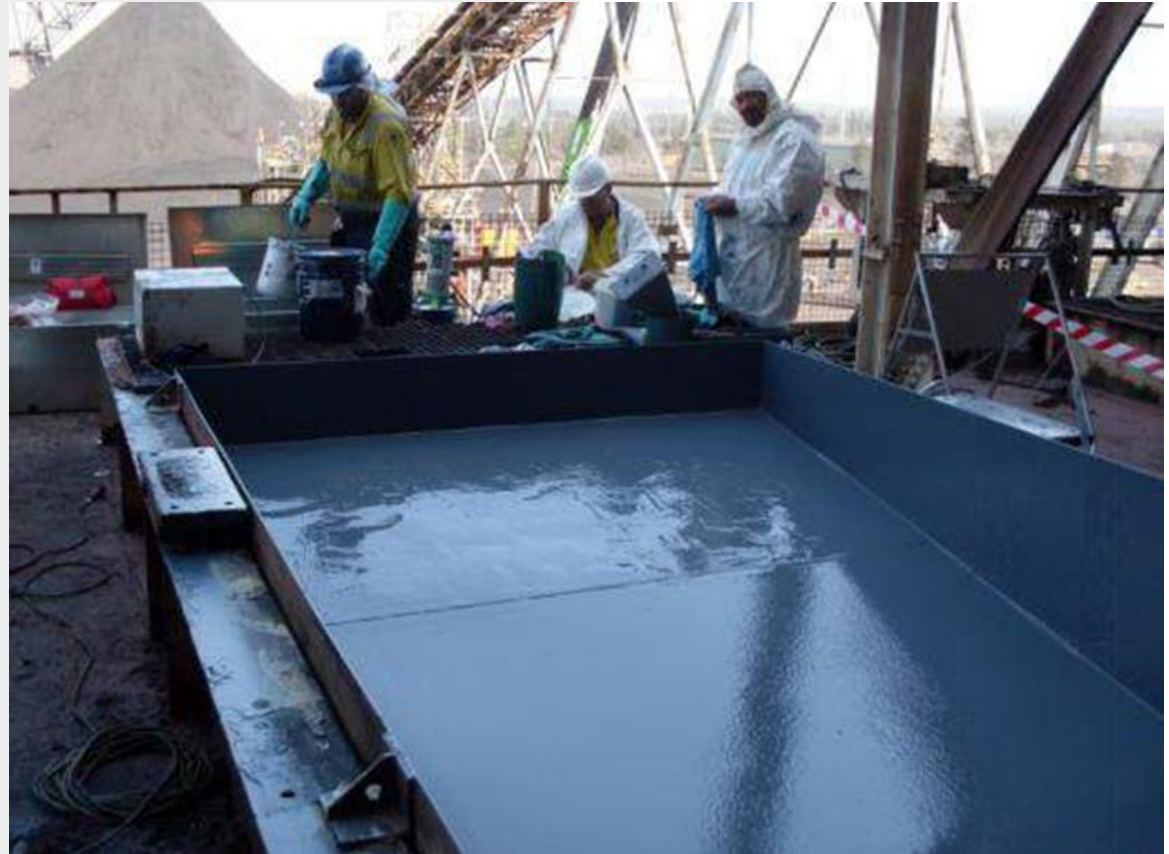
- The underpan was originally coated with polyurethane. The polyurethane was failing due to inter-coat adhesion issues and was coming off in sheets.
- This was causing pump blockages and leaving the under-pan susceptible to premature corrosion issues.

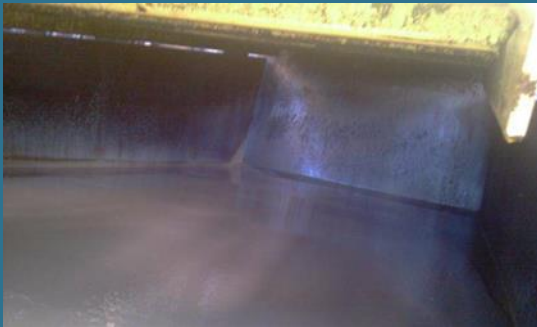
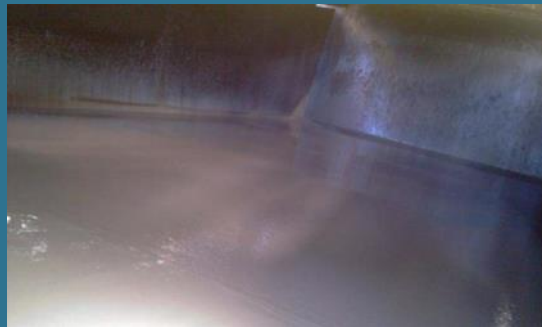
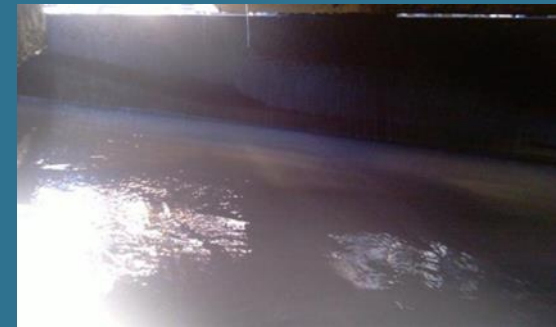
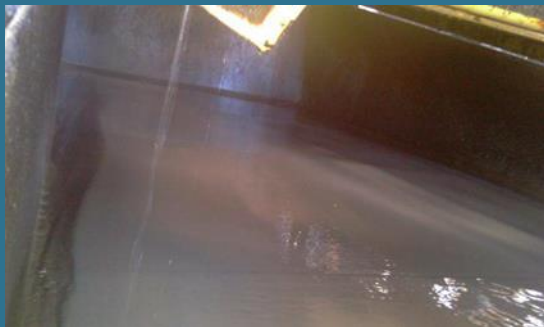
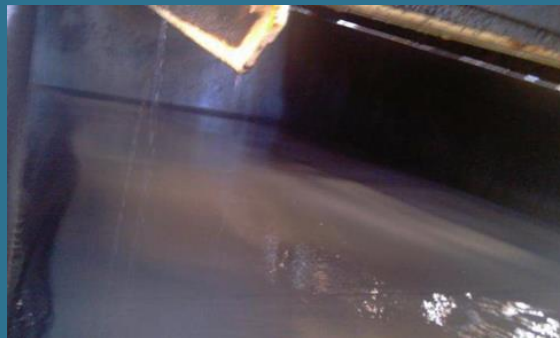
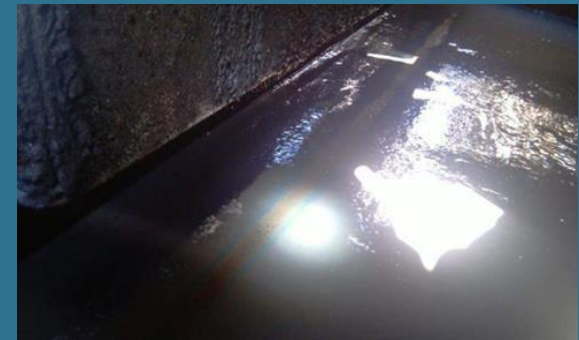
The following photos are from an inspection six months later. It can be observed that the top coat of Chesterton® ARC SD4i is untouched and the Chesterton® ARC BX2 coating is intact.
