COAL WASHERY SUMPS

SUMMARY

Plant: Coal Washery

Location: Blackwater, QLD

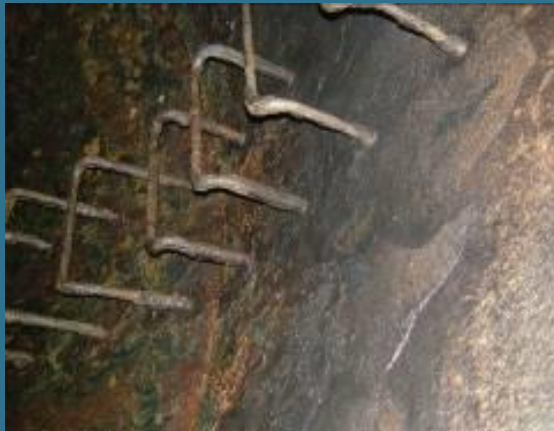
- Client was facing high sump replacement costs due to heavy corrosion.
- Severe pitting and holes in the sump.

Condition prior to re-grading

Imatech primed holes with Chesterton® ARC S2, then regraded to wall thickness with Chesterton® ARC 858. Remainder of severe pitting was then trowel coated with Chesterton® ARC BX2.

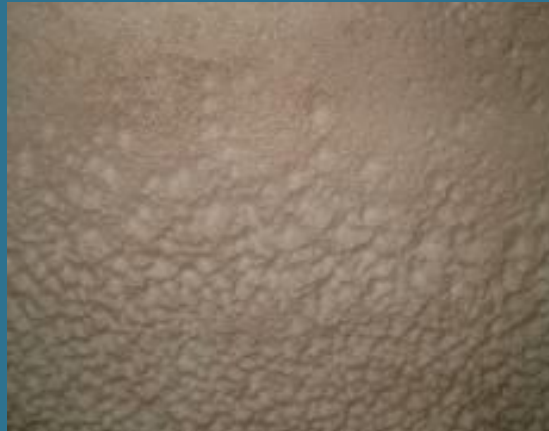
Blasted surface

Summary: Internals of de-sliming sumps were heavily pitted and holed out. Imatech water blasted the rust scales and the previous liner with ultra high pressure, then grit basted, regraded and lined the internals of the sumps with a combination of Chesterton® ARC 858, ARC BX2 and ARC S2 for a long term finish.

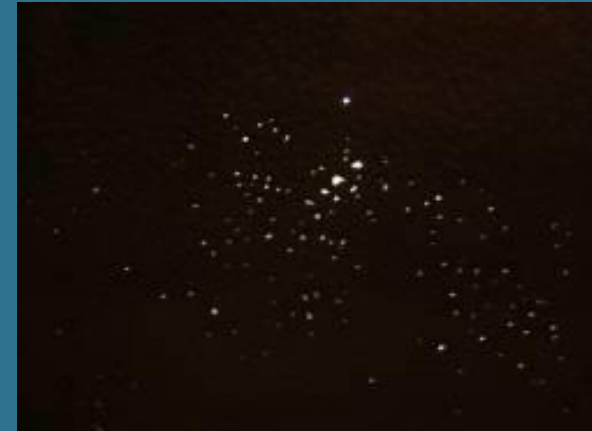
Prime coated

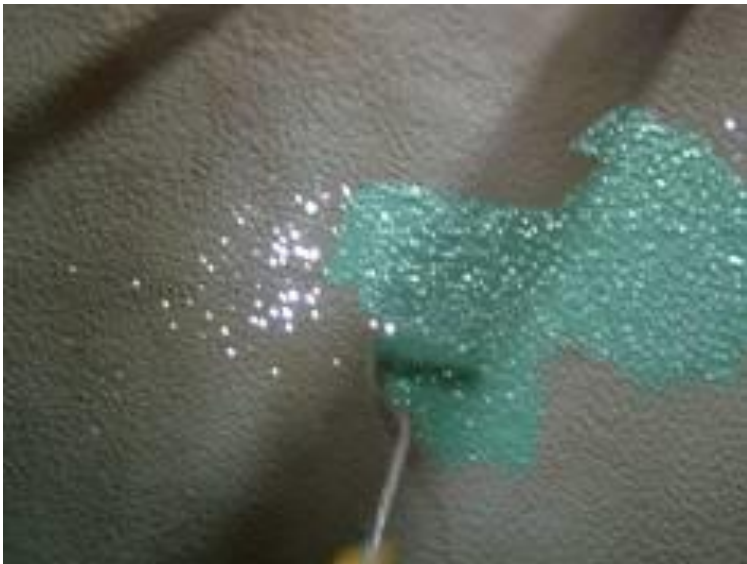
Prime coating with ARC S2 Green

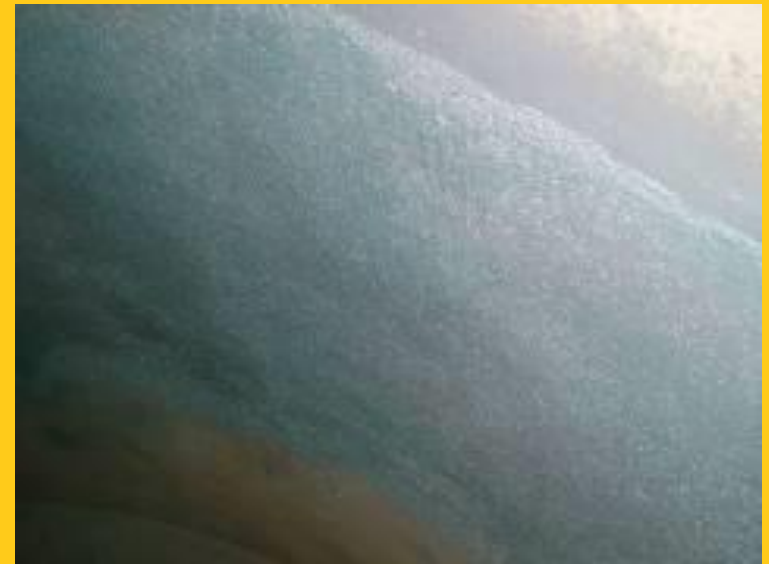
Final Coat ARC BX2 Grey

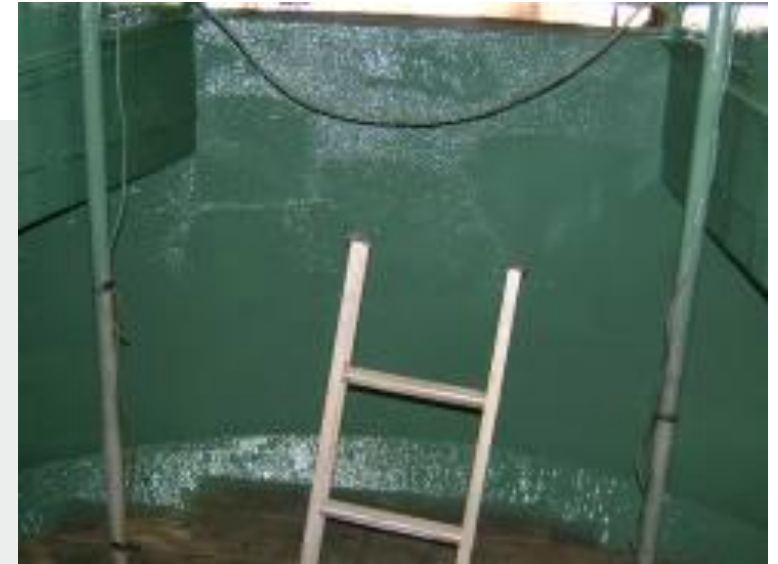
Initial prime coat

All internal surfaces were then coated with two coats of Chesterton® ARC S2 providing a long-term abrasion resistant surface.

The two coat, two colour system allows for easy wear identification when inspecting the coatings.

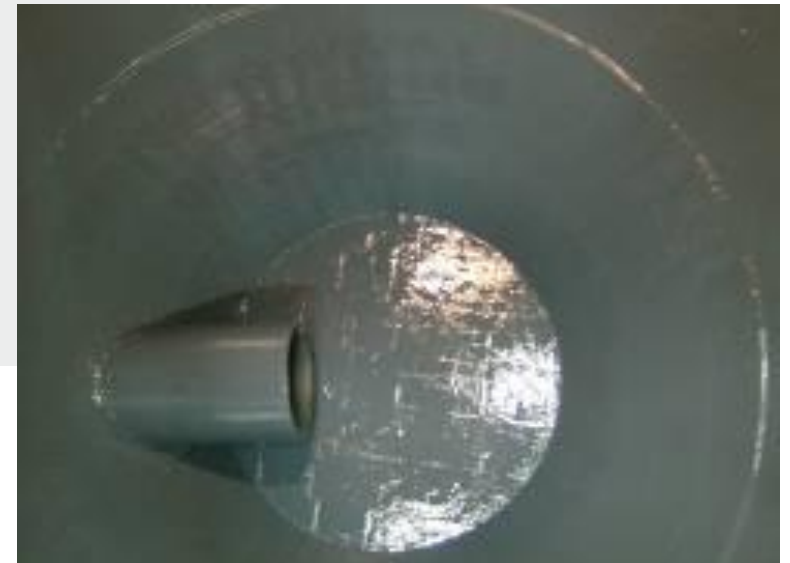
Final coat
