CORROSION REPAIR ON OUTER TANK BASE

Industry: Refinery

Equipment: Storage Tank

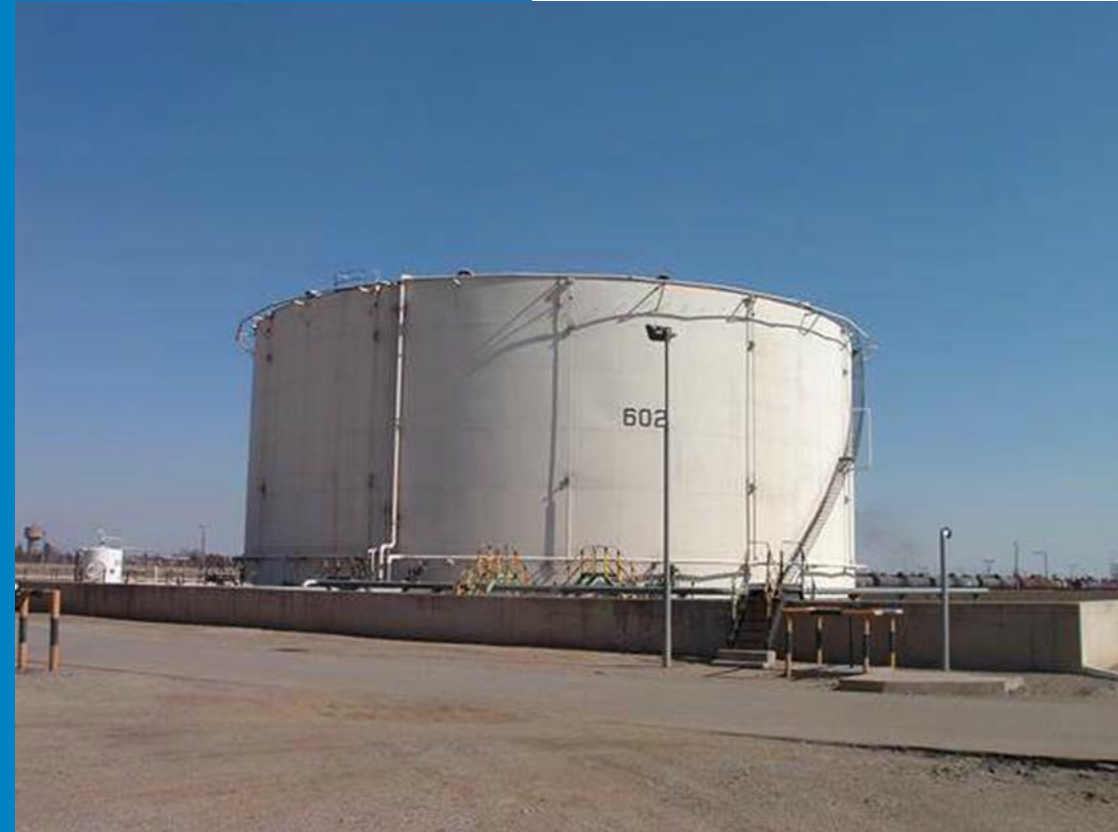
Corrosion of the outer tank bottom, the edges and weld seam.

Water collected in this area because the tank pad sloped towards the metal tank.

- Remove the bitumen cushion underneath the tank to a depth of 10 to 15 cm (4 to 6 in.) and a height of 4 to 6 cm (1.5 to 2.5 in.). After cleaning and preparing the exposed metal, apply two coats of Chesterton® ARC S1 covering this area including a strip of 30 cm (12 in.) above the bottom and around the tank.
- Chesterton® ARC 791 is used to reconstruct the bitumen base and to slope the surface towards the outside of the tank, preventing water from collecting under the tank. Final insertion of rubber gaskets and waterproof silicone sealant prevents any water infiltration.

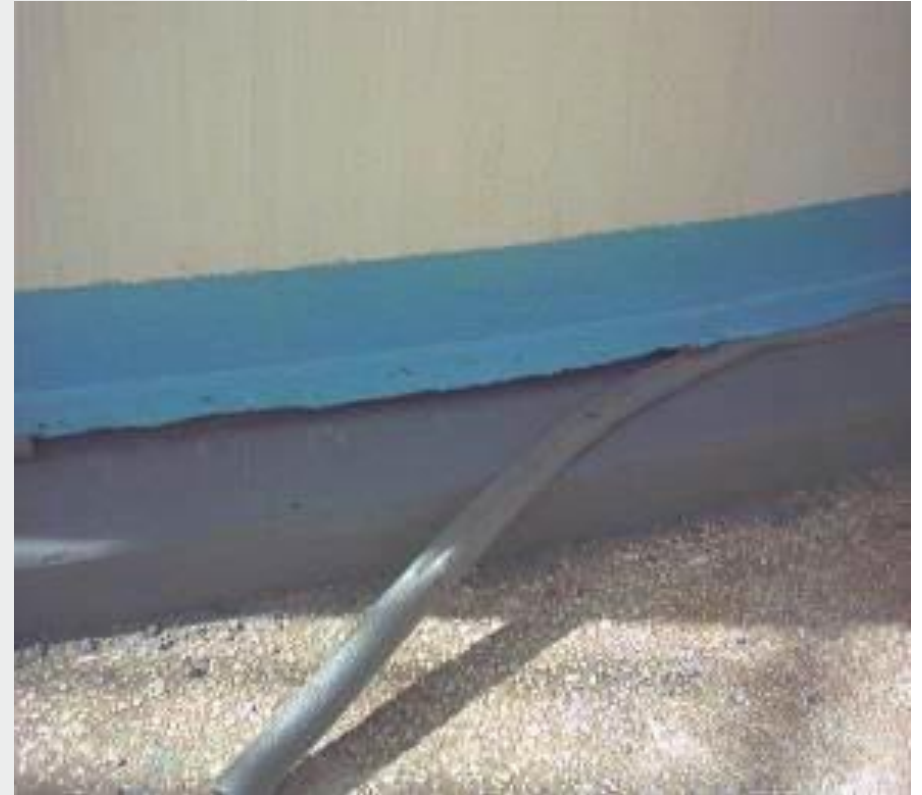
The first 6 tanks were completed in November 2003. To date, the application is still in perfect condition and the customer has completed the remaining tanks as well.
