LEAK TESTING USING G250 VACUUM GUNS

Summary: Identify leaking tubes on a chiller.

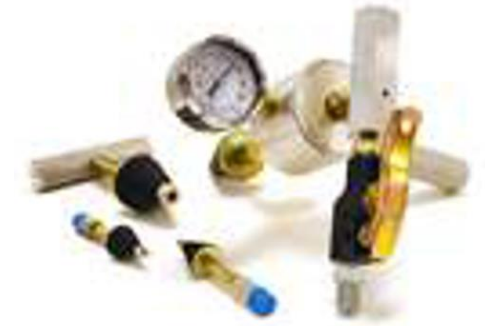
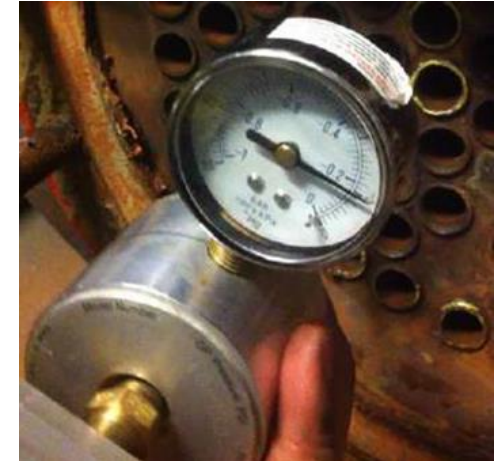
- G250 test guns were pressurized at 4 bar (58.02 psi/ 400kpa).
- A gun is plugged in at one end with plant air and a T-bar vacuum seal at the other side of the tube bundle.
- Plant air is pressurized to 60 PSI and a vacuum within the tube is created. A fail to create a vacuum would result in a leak being identified.

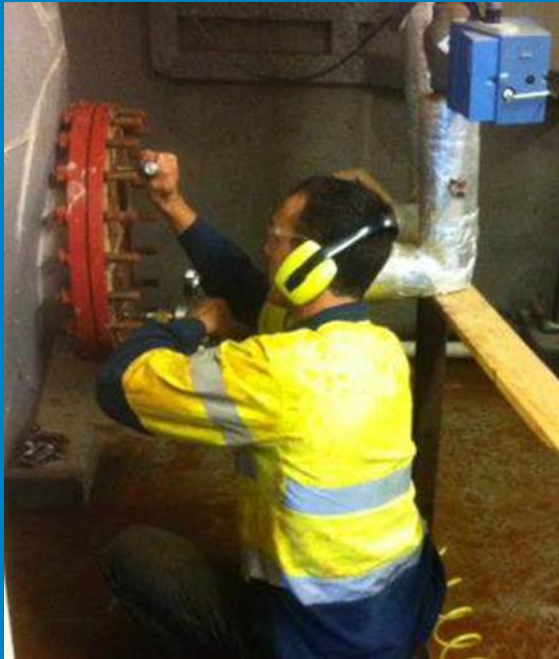
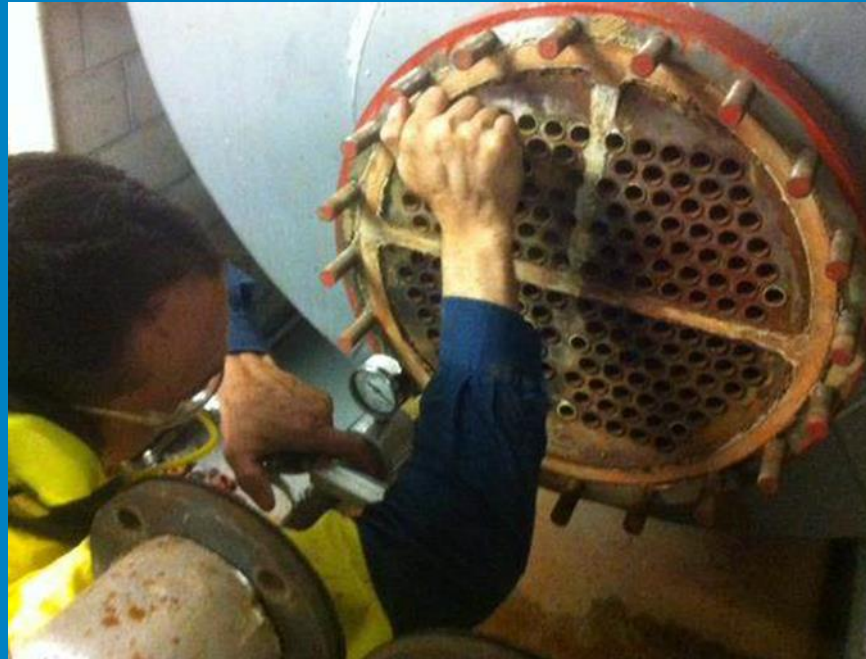
The above images demonstrate the G250 guns detecting leaks in the bundle.

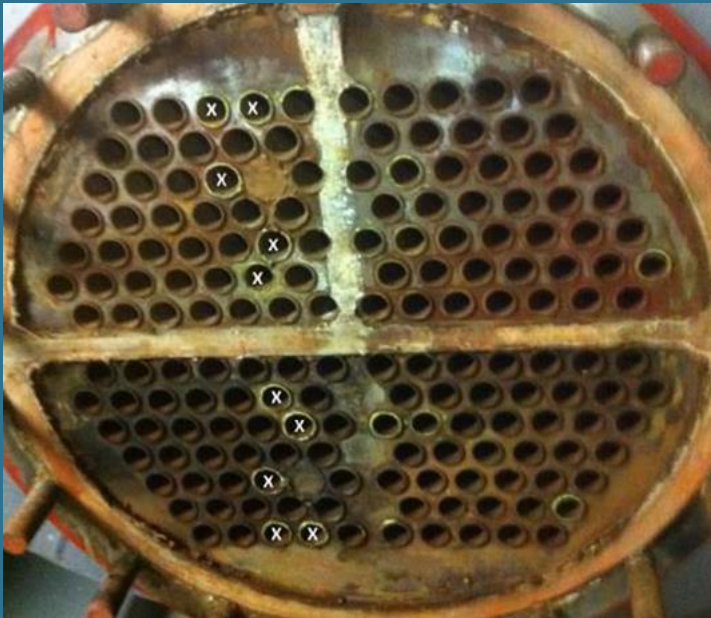
Leaking tubes identified.

U-Tube Bundle – Rows and Numbers to be read from Top or Bottom Left		
Row 1	Tube # 3 Tube #4	Leaks Present
Row 2		No Leaks
Row 3	Tube # 4 Tube #5 plugged up	Leak Present
Row 4		No Leaks
Row 5	Tube # 6	Leak present
Row 6	Tube # 6	Leak present
Row 7		No Leak
Total Number of leaking Tubes	5

- Due to unit efficiency decrease, the customer suspected leaking tubes and Imatech was engaged to perform the required test. The G250 Vacuum guns were used to find how many tubes were leaking.
- 5 leaking tubes were identified on the 17th April 2013, and 1 tube had previously been welded shut.
- Standard practice is to plug 7% of tubes before re-tubing the bundle.
- The above bundle has 86 tubes in total * 7% = 6 tubes to be plugged.
- Hole leaks identified are 5 and the previous welded plug = 6 plugged tubes.
- As the above results indicate, it is recommended that a more permanent solution is implemented before more leaks occur.
