REJECT SCREEN DISCHARGE CHUTE

Summary: Tile disbondment and heavy abrasion lead to a large hole in the chute that needed frequent patch ups. Chesterton® ARC BX2 was applied for the repair, outperforming all previously trialled products.

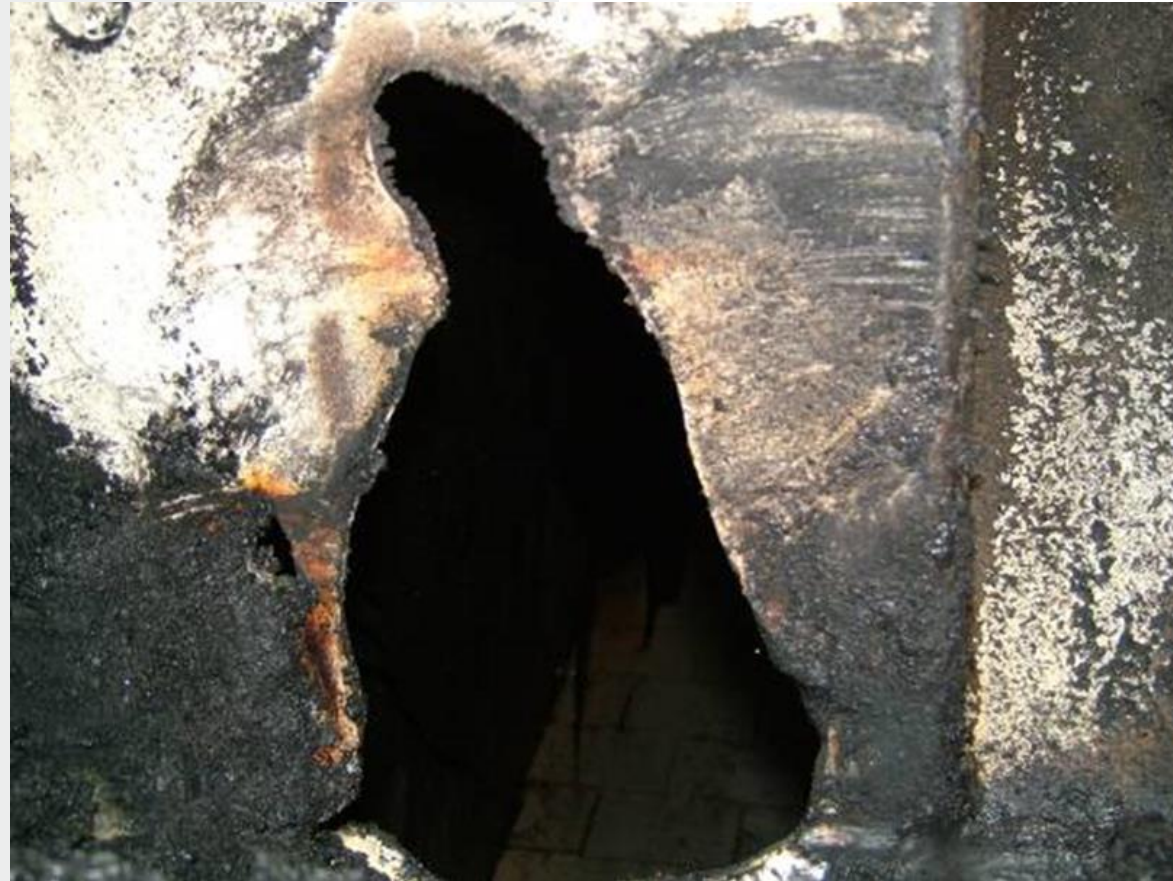
- Tiles were smashed and had disbonded in the chute due to high localised impact and wear.
- Previous wear resist patching needed repairs every 4 to 6 weeks.
- Confined space entry and difficult access lead to expensive labour costs.
