SUGAR MILLS
LG MOLASSES
VACUUM TOP PANS

Summary: Lining of mild steel LG Molasses Vacuum Top Pans for long term protection from corrosive attack.

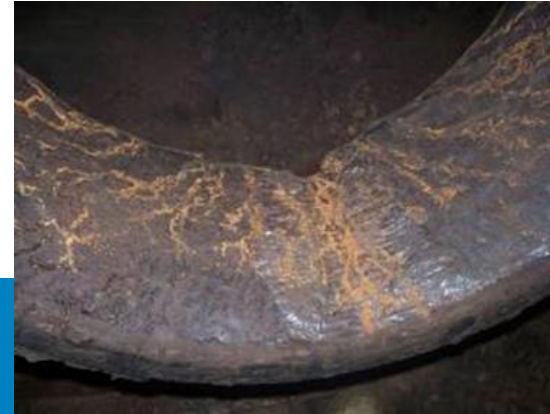
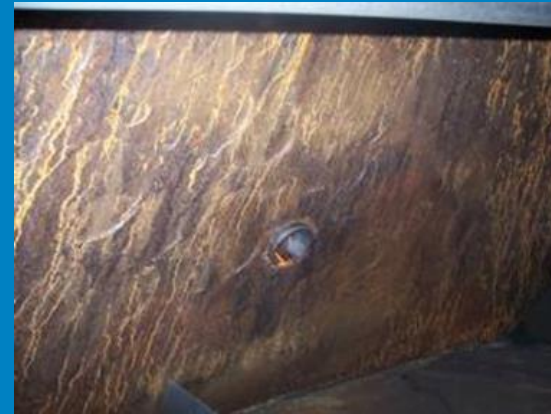
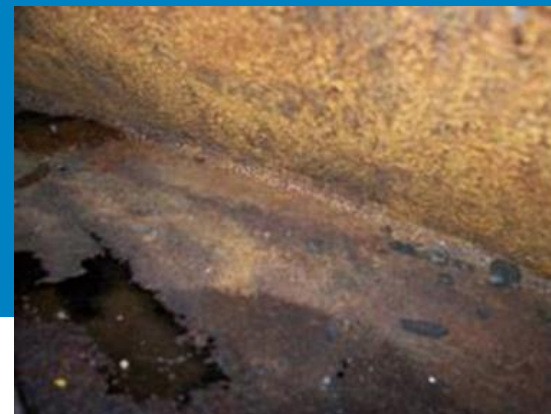
Previously, Imatech was requested by two Northern Queensland Sugar Mills to provide a suitable lining for long term protection against corrosion attack occurring in low grade vacuum pans. Volatile organic acids in vapour condensates typically attack the mild steel walls and vapour pipes in the pans.

The corrosive nature of this vapour/condensate at elevated temperatures works its way through 12mm boiler plates and attacks weld seams dramatically.

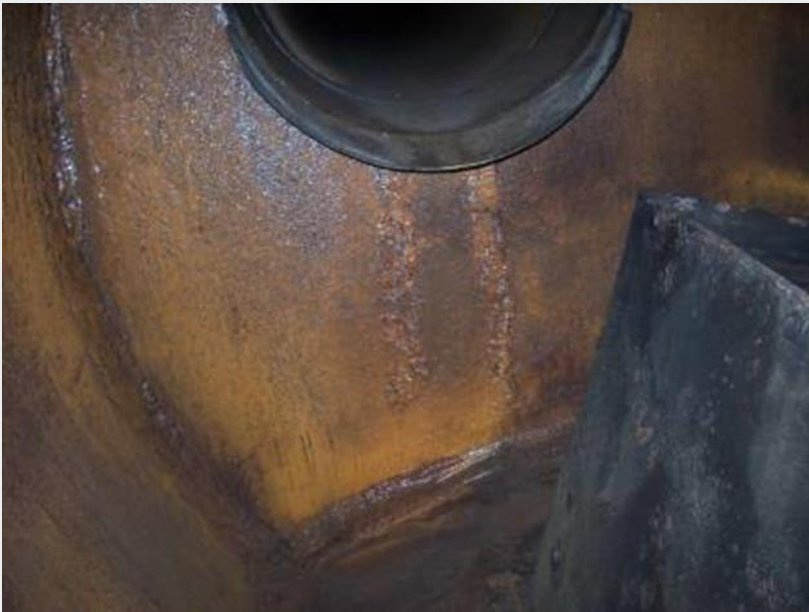
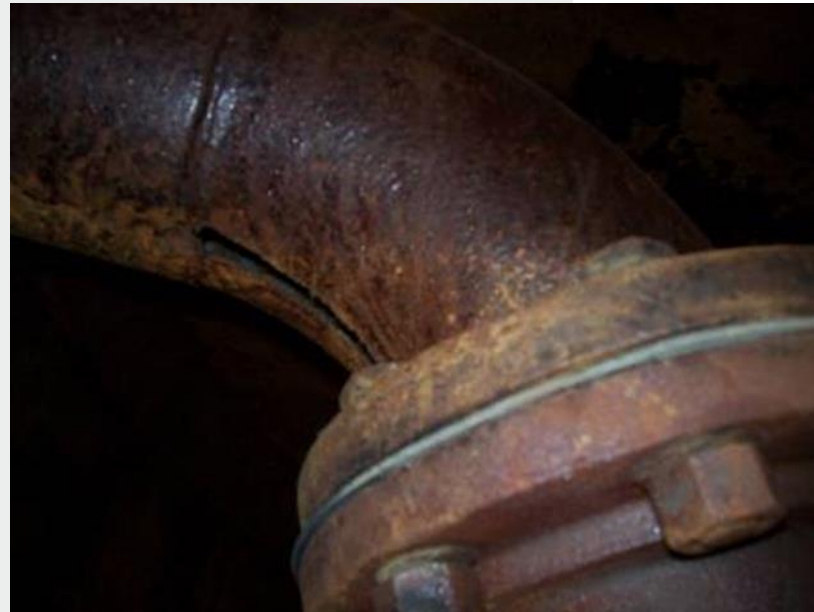
There is evidence of corrosion of the internal surfaces where the vapour condensate streams down the contours of the walls and fittings.

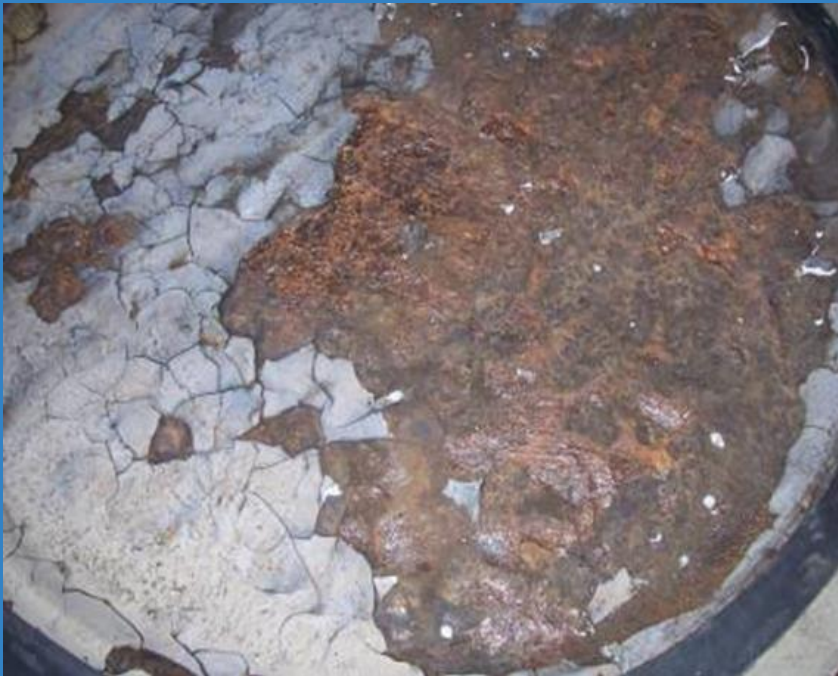
The manufacturer's two part epoxy coating is pictured here after three seasons in service. The degree of corrosion under the coating suggests failure possibly during the first season.

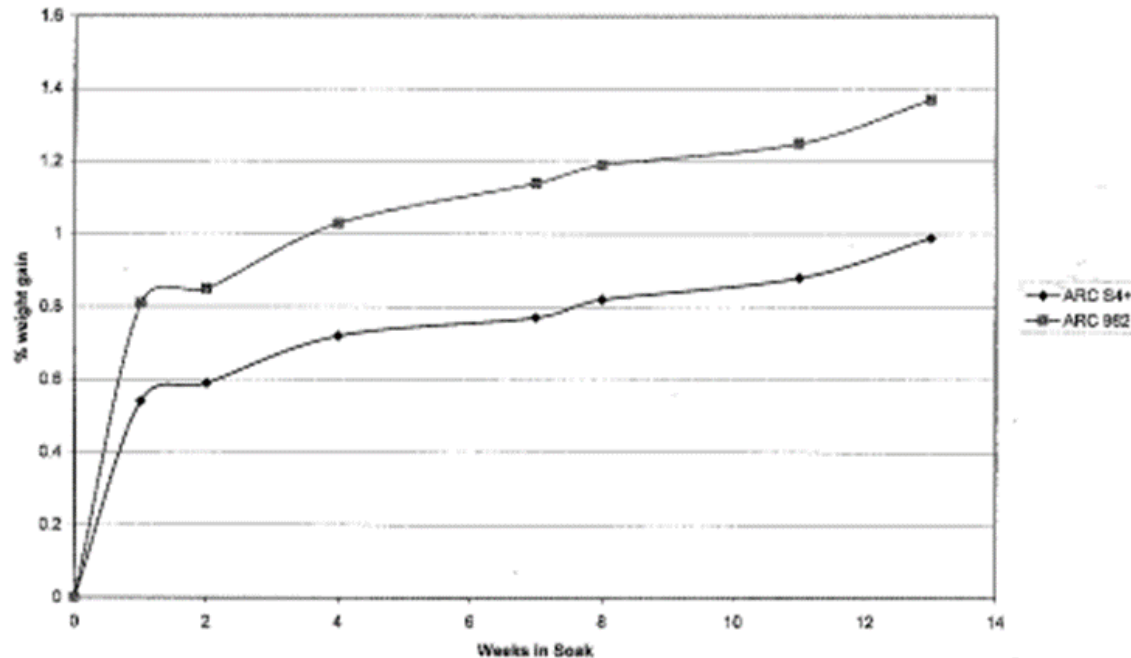
Soak test in Imatech Condensate

- In addition to chemical analysis of the condensate, Imatech transported a second batch to our Boston, U.S.A. laboratory facilities for controlled soak testing. Two selected linings were exposed to the condensate in an environment designed to accelerate potential coating failure.

- The results displayed in this graph show a percentage weight gain as low as 1% after 13 weeks. Although this result suggests that Chesterton® ARC S4+ was suitable for long term continuous immersion service the samples were tested for a much longer period with a resulting gradual decrease in the rate of weight gain.

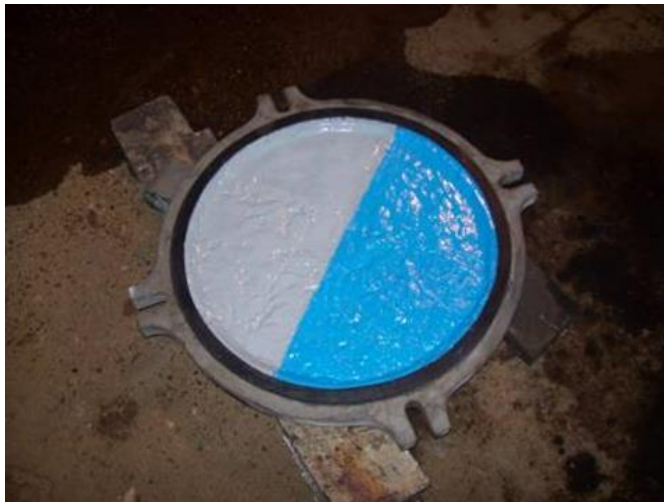
In addition to the laboratory testing this exposed section of an LG Top Pan manway hatch was prepared and coated with two Imatech linings identified as being suitable.

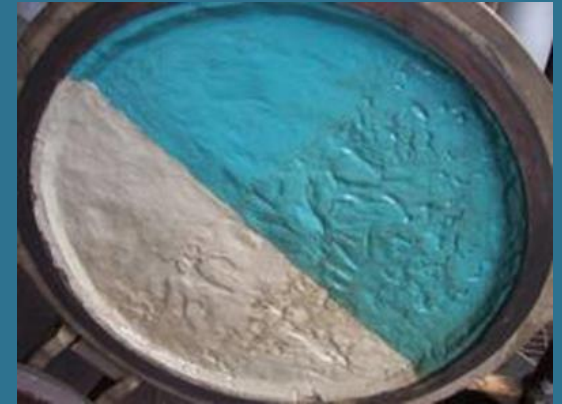
First Season

After the first and second season, the lining is in great condition with no blistering, cracking or deterioration.

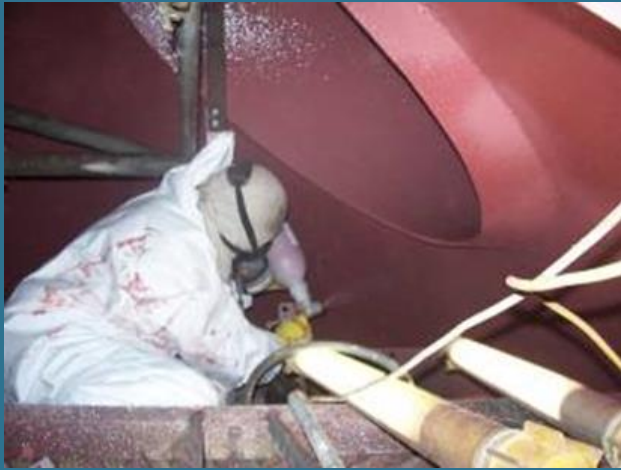
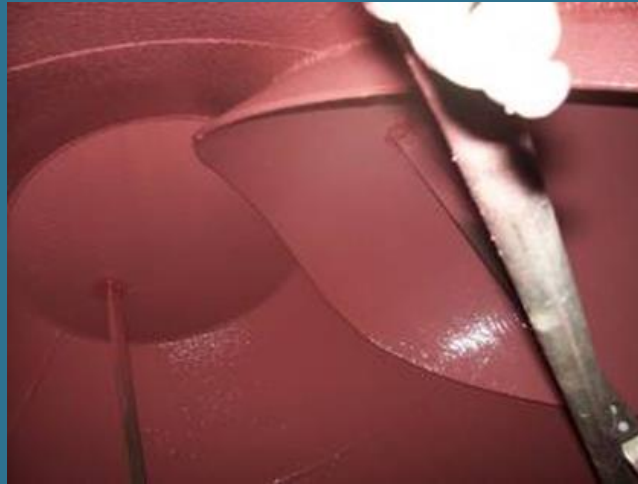
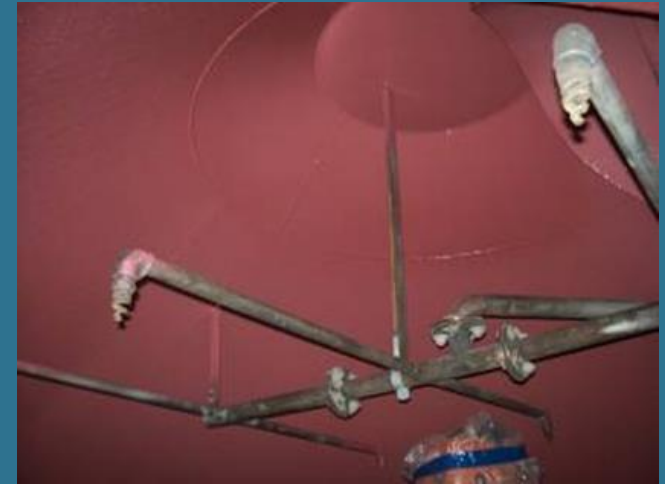
Based on the laboratory and manway hatch results, a LG Vacuum Top Pan was prepared and lined by Imatech applicators with Chesterton® ARC S4+ at the beginning of the next season.

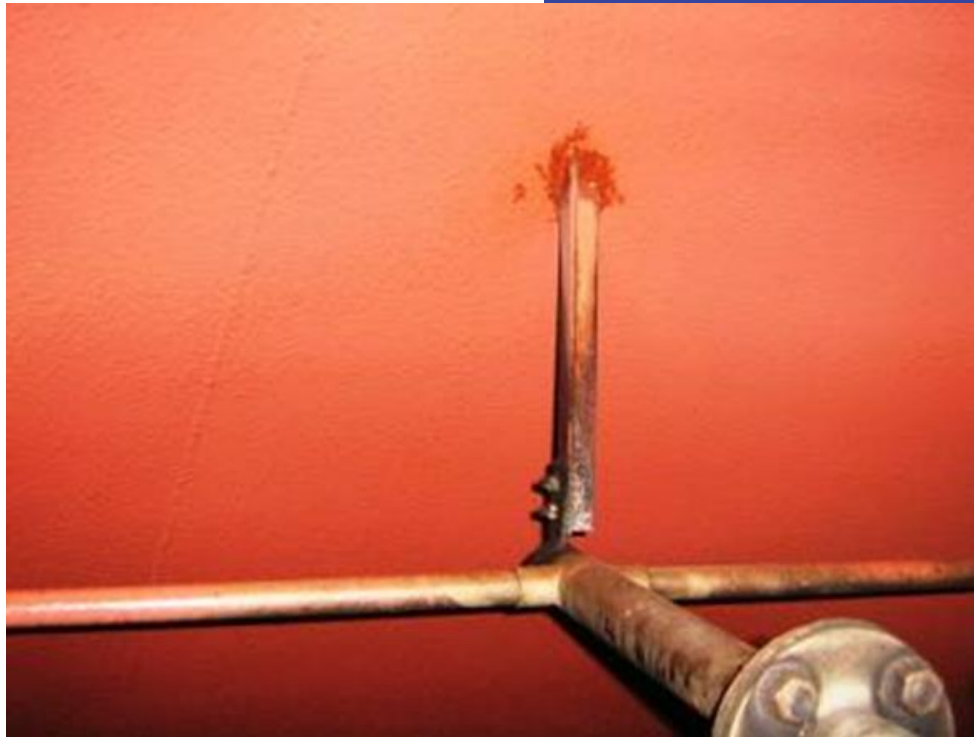
After one year, the inspection of this Pan has shown very good results. The coating is in great condition and the mild steel surface will be protected from corrosion for more seasons to come. A further three Pans at these Sugar Mills will now be coated with Chesterton® ARC S4+.
