**NEWCREST – LIHIR  
OPERATIONS,  
LONDOLOVIT WEIR  
PUMPS**

**Industry:** Gold Mining / Mineral Processing

**Product:** 4 off Vertical Turbine Pumps

**Location:** Lihir island, New Ireland Province, PNG

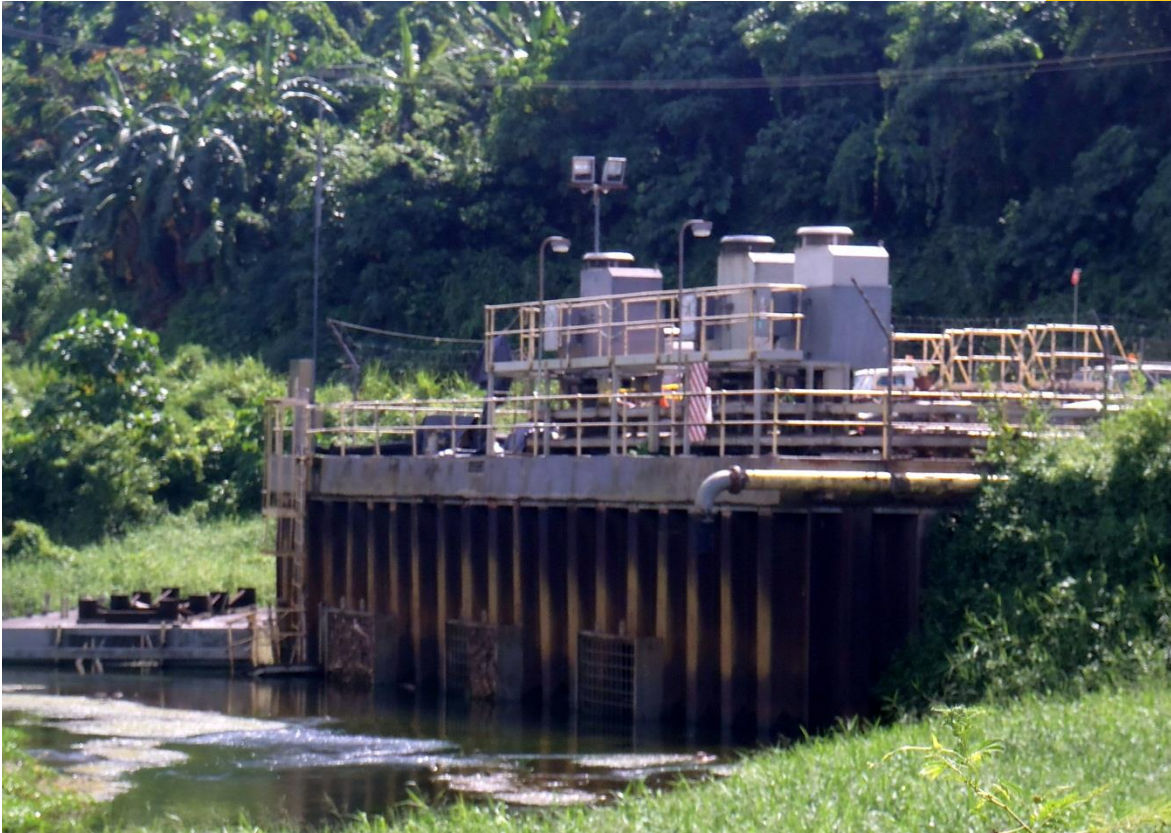
# PUMP OVERVIEW

- Pumps are currently used for the Pumping of Freshwater from the Londolovit Weir on Lihir Island to the Process Plant and are considered a critical asset.
- 4 Pump Stations available on Pump Platform, 2 Pumps running continually with 3<sup>rd</sup> Pump running when demand requires, 4<sup>th</sup> Pump Station is a Spares situation.
- Pumps are not performing in line with clients expectations in regard to service life and performance.
- OEM Parts are very expensive and are on long lead time supply. (Expensive Inventory situation)
- Lack of support from OEM to on site issues.

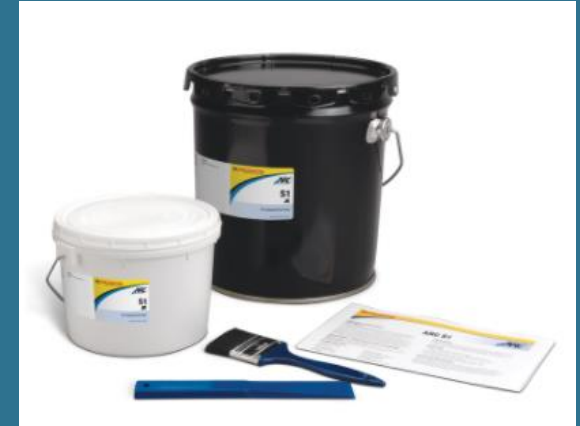
All External of Pump were coated with **Chesterton® ARC S1**

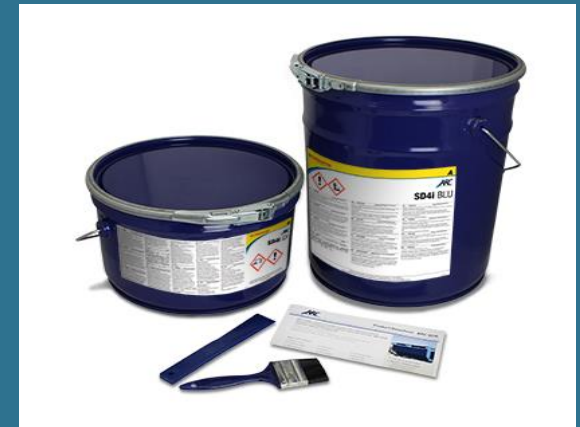
All Internal wetted parts of Pump were coated with **Chesterton® ARC SD4i**

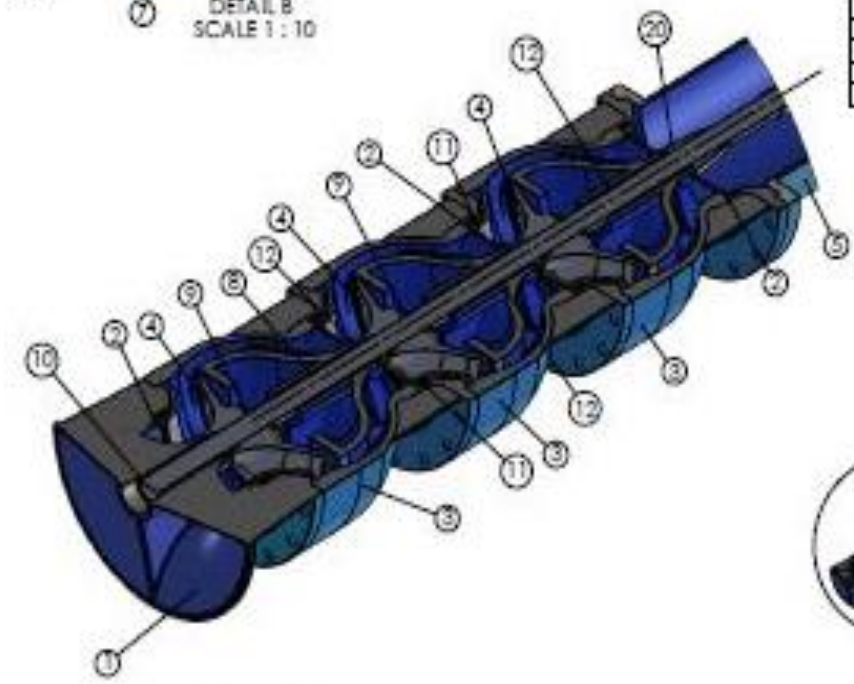
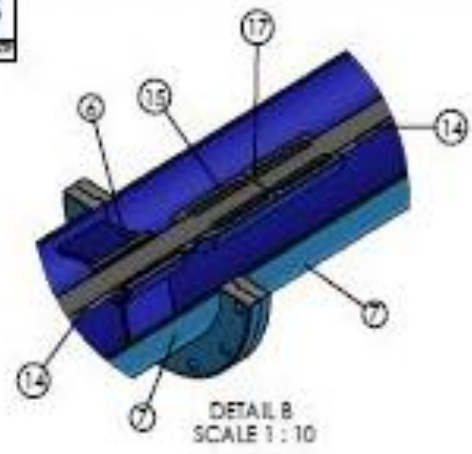
ITEM No.	PART No.	DESCRIPTION	QTY.
1	IS1256	Suction Bell	1
2	IS1299	Flanged Wear Ring	4
3	IS1280	Sowl	3
4	IS1254	Impeller	3
5	IS1250	Lower Column	1
6	IS1262	Column bearing	4
7	IS1289	Column - Intermediate / Upper	3
8	IS1297	Pump Shaft	1
9	IS1292	Impeller Split Ring	3
10	IS1300	Suction Bell bearing	1
11	IS1303	Impeller Wear Ring	3
12	IS1304	Sowl bearing	3
13	IS1305	Lower Shaft	1
14	IS1306	Intermediate Shaft	2
15	IS1309	Split Coupling Counter Bored	4
16	IS1308	Split Coupling Threaded	4
17	IS1307	Coupling Split Ring	8
18	IS1311	Discharge Shaft	1
19	IS1314	Threaded Coupling	1
20	IS1319	Deflation Cone	1
21	IS1312	Top Shaft	1

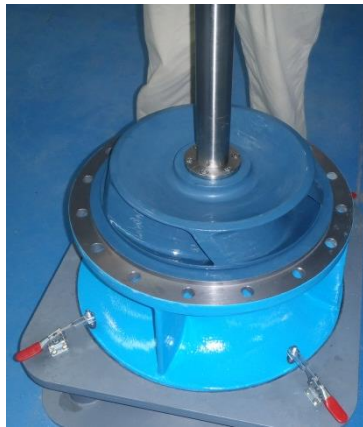
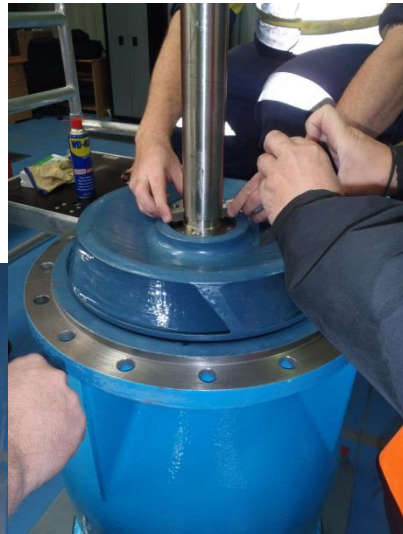
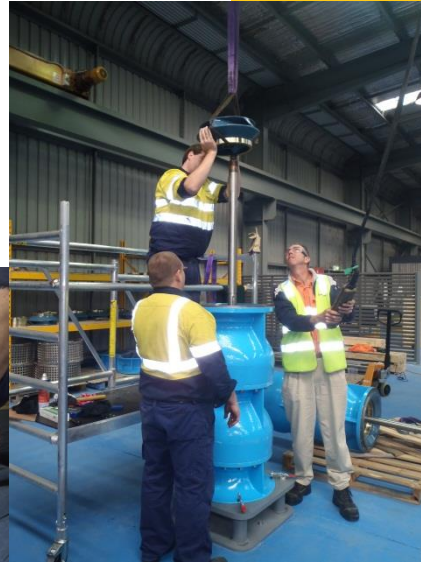
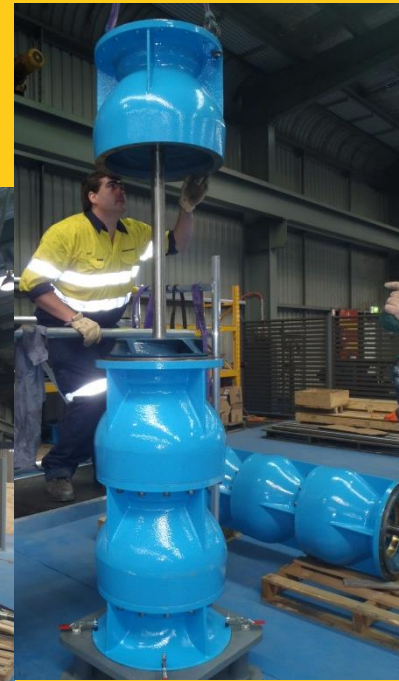
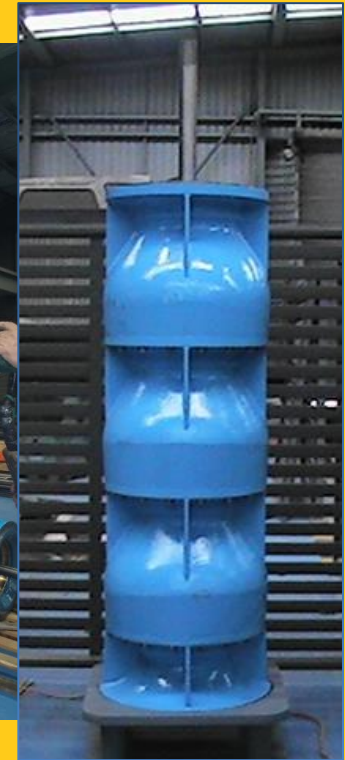
# Wet End Assembly & Inspection by Newcrest

- As per contractual arrangements all the Wet End Assemblies would be assembled in our Geelong pump repair facility by Imatech to ensure correct procedure is followed.
- Newcrest Representatives from the Lihir site were in attendance whilst all assemblies were built

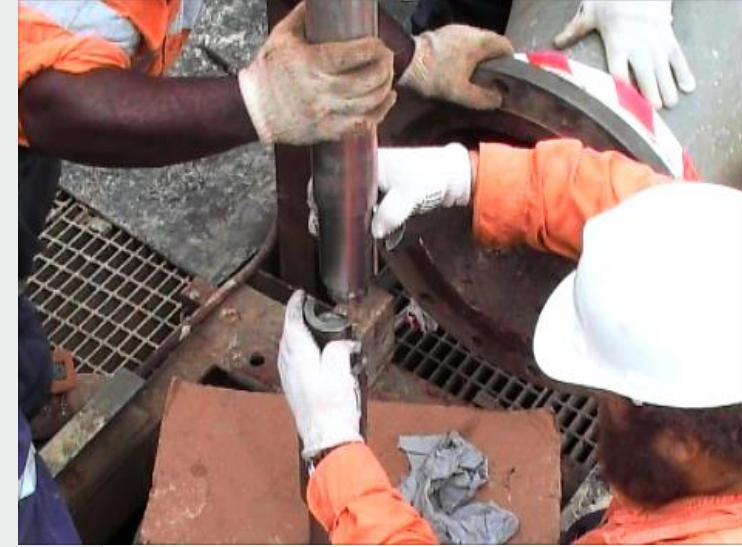
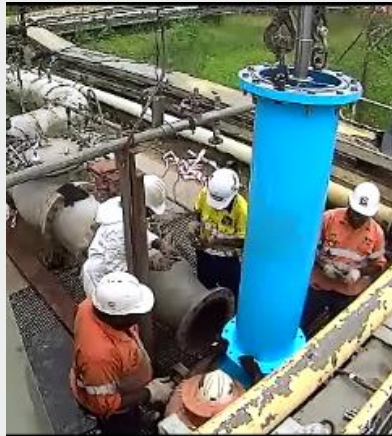
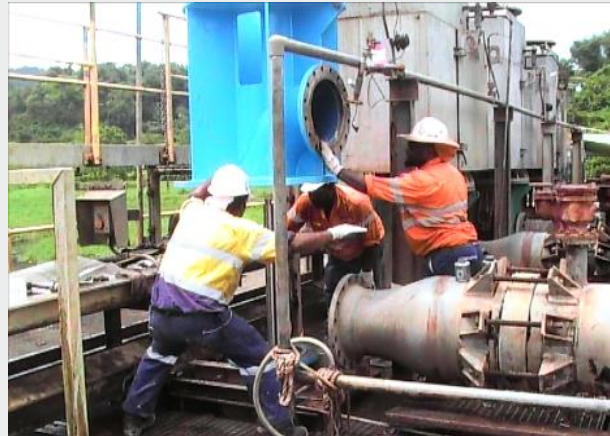
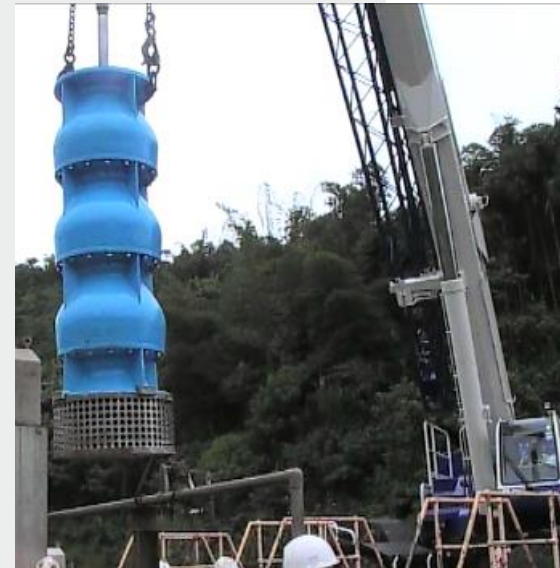
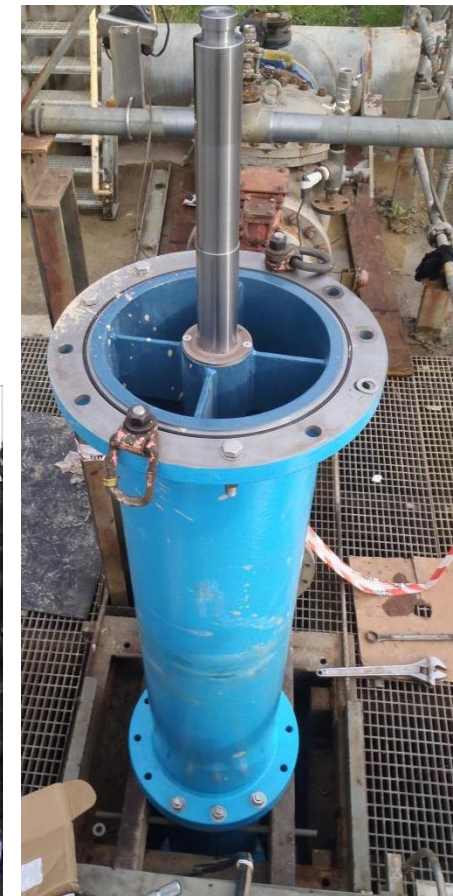
# ASSEMBLY ON SITE

- Imatech travelled to Lihir site to view installation of first 2 Pumps that arrived on site
- It was decided that only 1 Pump would be installed and run to confirm its performance for around 4 Weeks then the 2<sup>nd</sup> Pump would be installed on site
- Imatech performed flow rate (m<sup>3</sup>) readings of all 3 OEM londo Pumps that were running before installation of Imatech Pump
- During Assembly process Imatech viewed areas where fixtures and assembly tooling needed to be manufactured to assist assembly procedure
- Once Pump was installed and running on site flow readings were taken of Imatech Pump
