Feed Pipe

CASE HISTORY

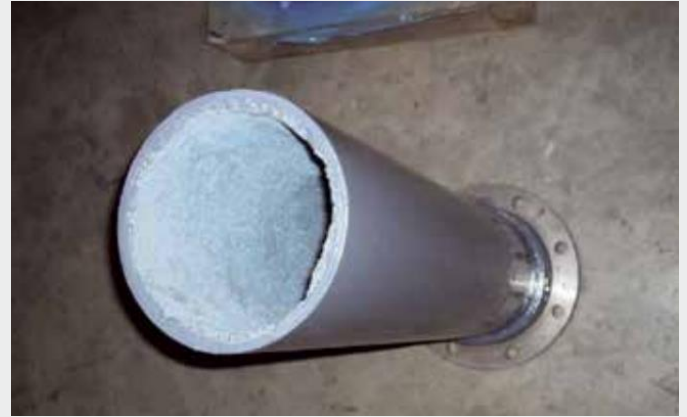
Feed pipes transporting an abrasive Gold slurry were failing after just 3-4 weeks. This resulted in excessive costs from replacement pipes, labour and lost productivity.

Discharge feed Pipe

Following discussions with the client and an analysis of the service conditions, Imatech proposed that the feed pipe be upgraded to the ArmorPIPE™ 9200 Series specifications. This system consists of a carbon steel pipe lined with an energy absorbing ceramic polymer.

Pipe size and schedules are selected, which allow room for the lining, while maintaining the dimensional and pressure requirements of the system. This unique design is capable of withstanding extreme abrasion without the brittleness normally associated with traditional ceramic materials

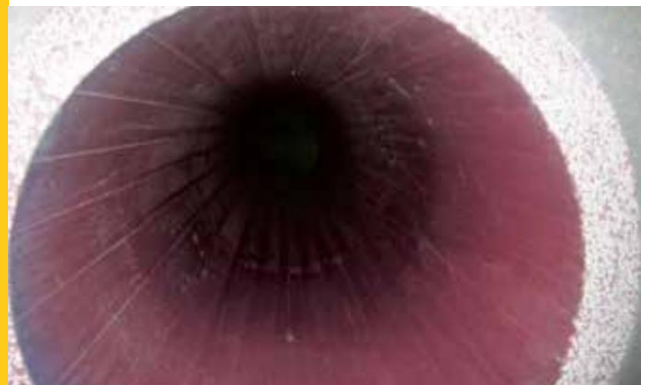
9200 Series ArmorPipe™

- The pipes were inspected 16 weeks after installation (4x life of previous equipment) and no visible signs of wear were found.
- The total service life exceeded 72 weeks (20x life of previous equipment).
- As a result of this success, savings were realised in pipe purchases, maintenance costs, downtime and a reduction in associated administrative and warehousing costs.
- The estimated overall savings per pipe were \$10,000 to \$15,000 p/a.
