# LEACH TANK REPAIR

## CASE HISTORY

- INDUSTRY** : Gold Mining
- PRODUCT** : ARC SD4i, ARC BX2 and ARC 858
- PLANT** : Leach Tank
- LOCATION** : Cracow, QLD, Australia.
- SUMMARY** : Imatech received an emergency call to repair a Leach Tank. The tank had holed out, which meant the plant was only running at 80% capacity. Imatech mobilised and started repairs 48 hours from receiving the call.
- ROI** : The client was up and running at full capacity within 3 days; saving significant downtime and money.

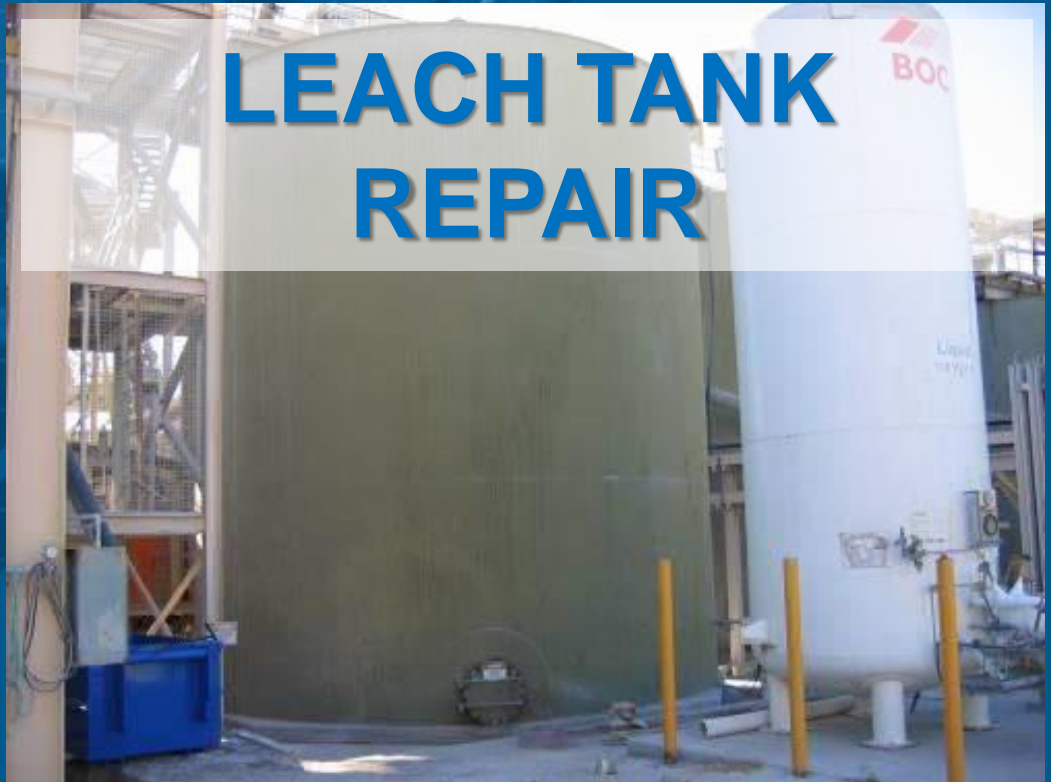
The tank floor had holed out the entire way around the base, due to corrosion. This caused major problems with chemical substances leaking from the tank; leading to removal from service.

- The entire base and 1m up the sidewalls was abrasive blasted.
- A SCAT test was carried out revealing high levels of salt in steel. This was treated, bringing it down to acceptable levels to ensure longevity of coating.

Surface was then re-blasted to achieve a 75µm to 120µm profile and ARC 858 ceramic regrading compound applied to repair major holes.

- A blend of ARC BX2 (trowelable) and 30% ARC SD4i (sprayable) was mixed to produce an abrasive and chemical resistant slurry.
- This was easily trowelled around the entire 27m perimeter of the tank repairing and protecting the heavily pitted surface and providing a smooth surface to spray apply the top coating.

A two-colour ceramic composite system was then spray applied to the entire internals of the tank.

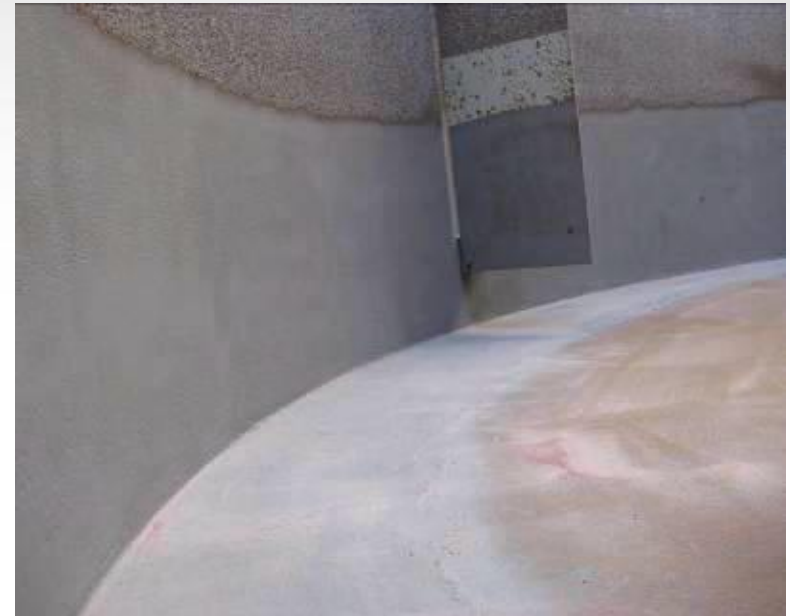
*Trowelable Ceramic Composite*

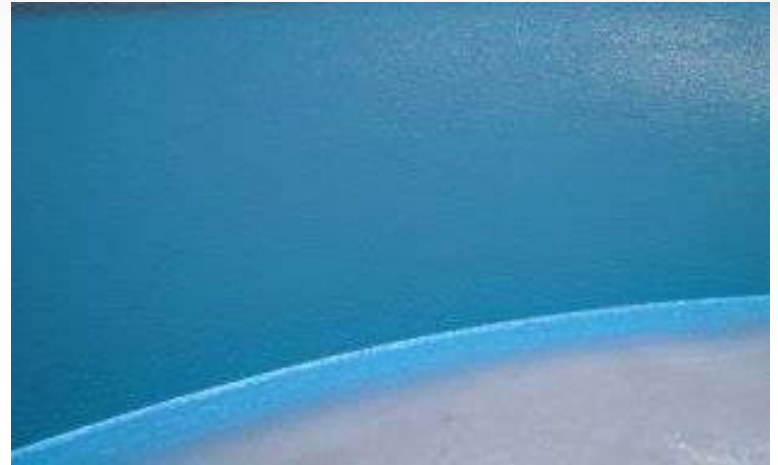
As Imatech had effectively started repairing the tank 48 hours from receiving the call, the client was able to get back to service and run at full capacity within 3 days. Conducting the repair on time saved the client significant downtime and money.
