PRECIPITATOR AGITATOR BLADES

CASE HISTORY

INDUSTRY : Alumina Processing Plant

PLANT : Alumina Refining

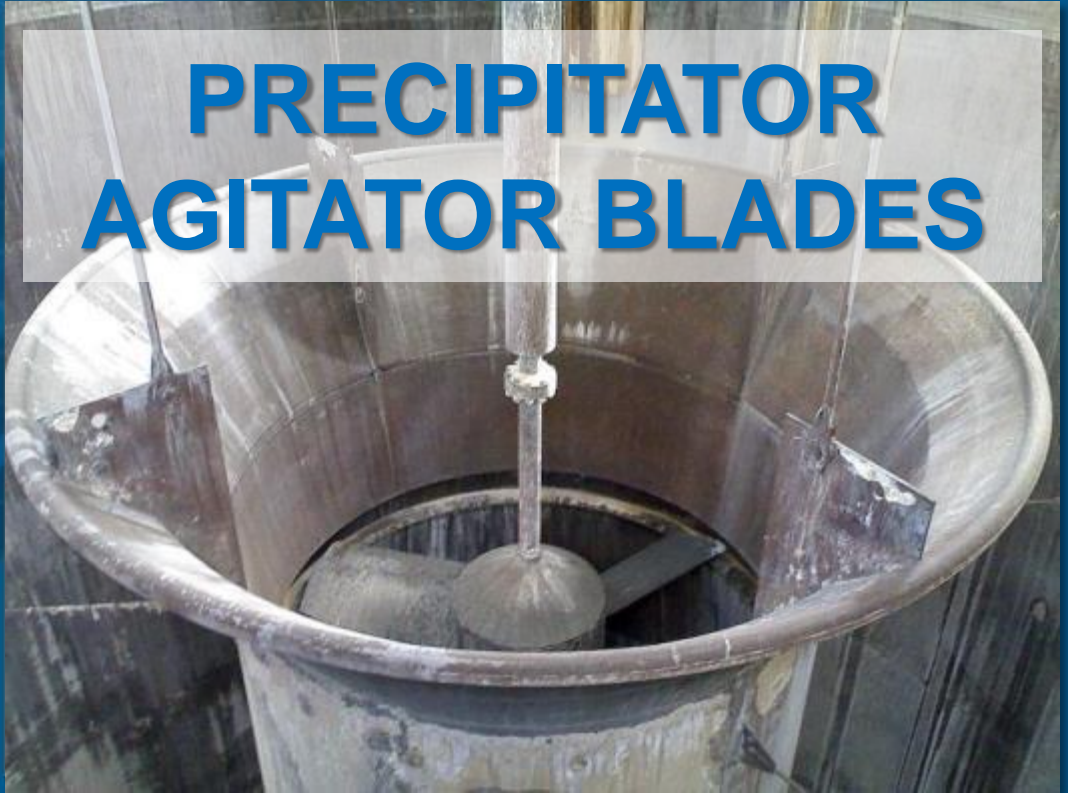
SUMMARY : The precipitator agitator blades were badly damaged and the turn around time on repairs was too long. With the repair of the blades with our ceramic composites, they were provided long term protection.

The blades are currently being coated with Metco 43C nickel chromium alloy and Metco 136F chromium oxide-silica composite powder. Even though they were lasting ~5 years, they were badly damaged. Repairs with the previous coating, took 3 – 4 weeks to repair at a cost of approximately AU\$30,000.00.

- The plates needed to be welded inside the large holes to close them.
- The entire set of blades needed to be abrasive blasted.
- Smaller holes then have to be filled with ARC BX1 and then shaped.
- The leading edges and tips of the blades have to be coated with 3mm of ARC PYRO MX3.
- Finally, the entire set of blades have to be coated with two coats of ARC 855 HT.
