EFFLUENT DOSING PIT

CASE HISTORY

SUMMARY : Removal and replacement of delaminating bitumen and impregnated latex membrane.

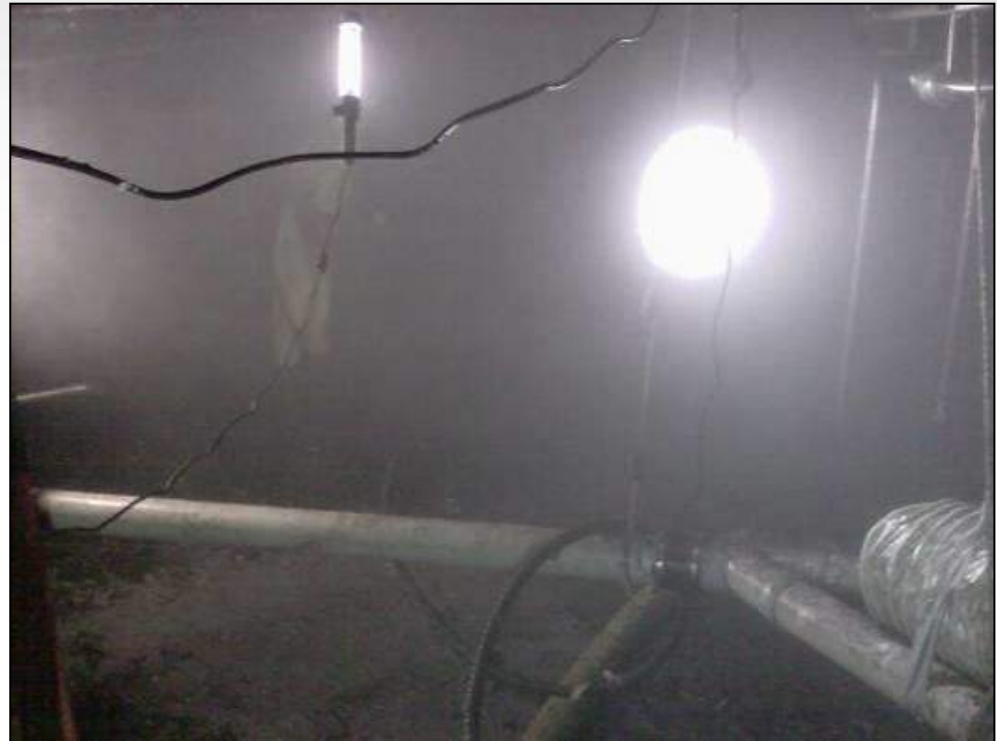
- Hydro blasting used to remove the coating from all surfaces, followed by a wash with Chesterton 360 Phosphate free cleaner to saponify and remove fatty waste.

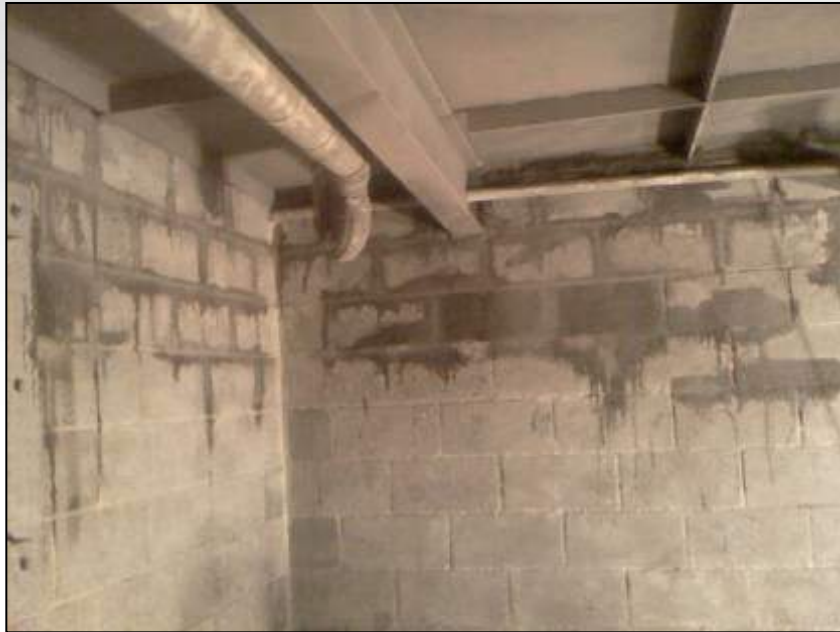
- Dust extraction system shown to control environmental hazards.

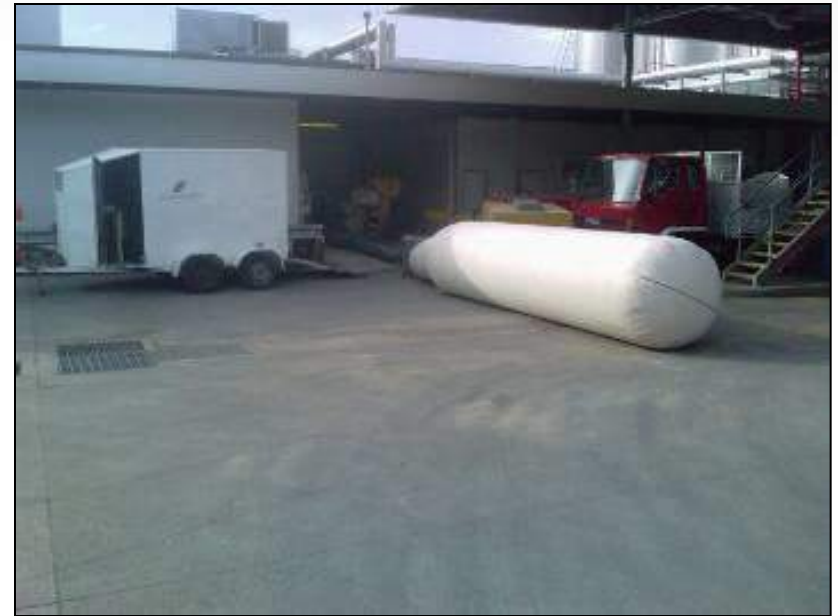
- Steel surfaces cleaned and profiled by abrasive blasting.

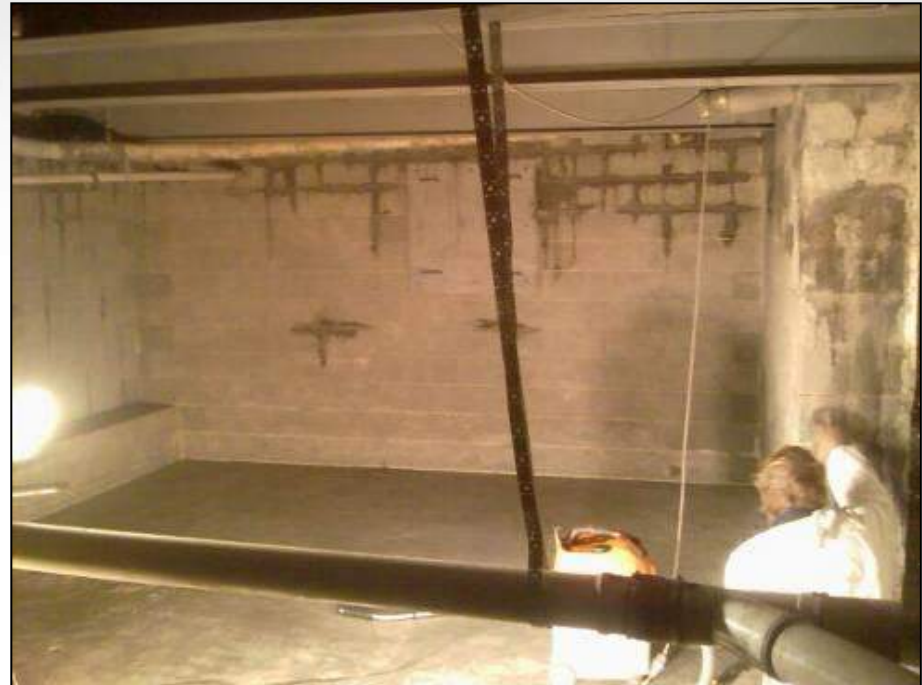
- Damaged mortar joints and concrete repaired with quartz reinforced composite to achieve an acceptable surface for top coating.

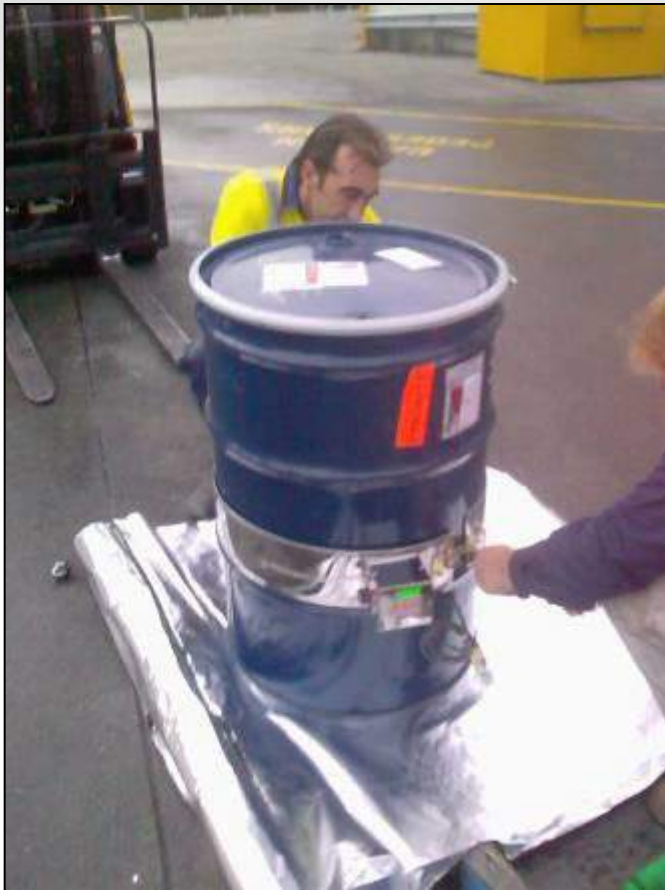
- After preheating the ARC S1HB composite, the temperature was monitored and maintained at a level ideal for application.

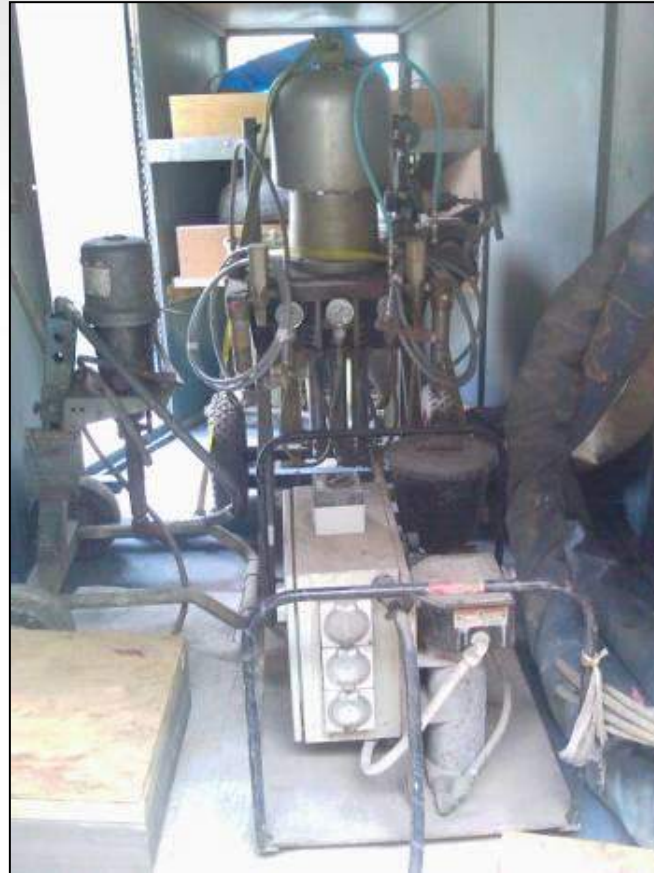
- Fixed ratio, plural component spraying equipment was utilised to reduce application time and ensure the coating thickness is uniform.

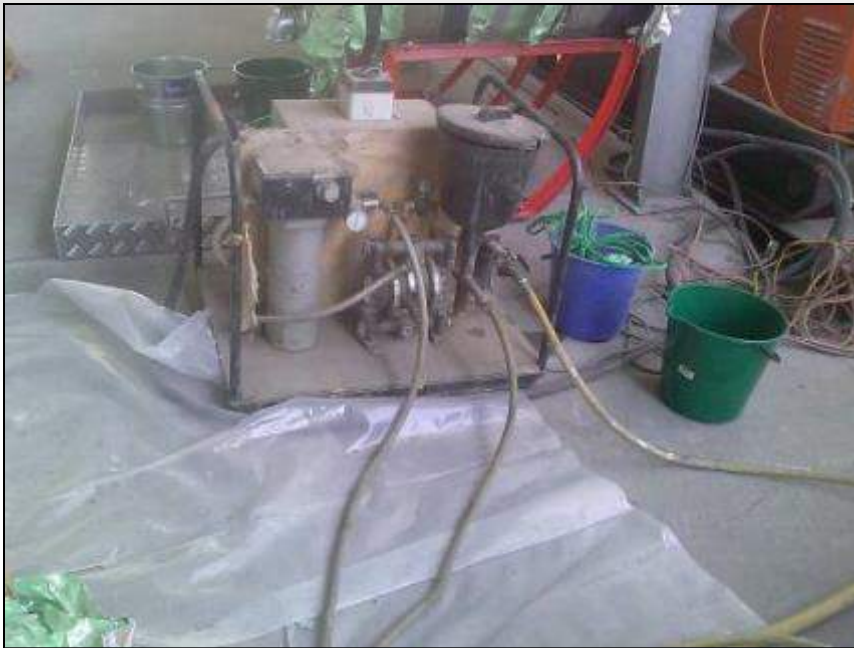
- Inline heaters were used to keep the products viscosity at optimum levels for spray application.

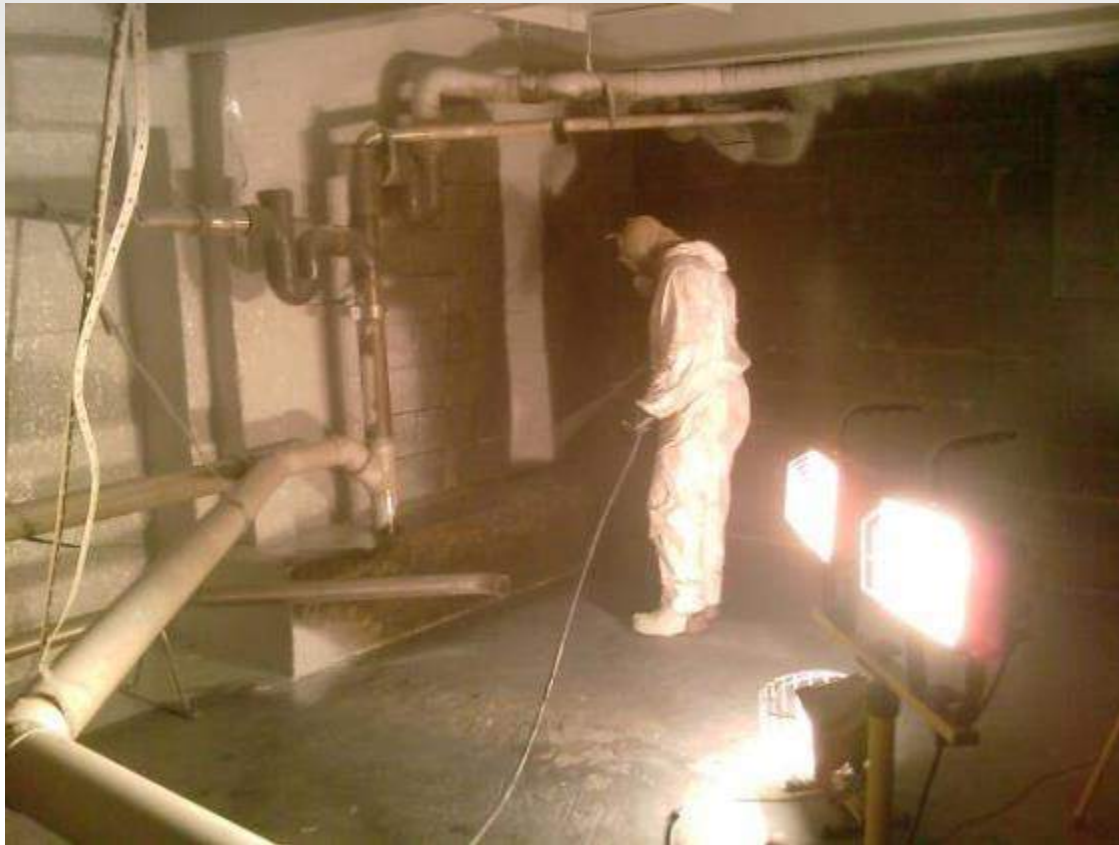
- All surfaces are coated with 2000-2500µm ARC S1HB, to provide a smooth, chemical resistant surface which is easily cleaned and maintained.
