# LEAK TESTING USING G250 VACUUM GUNS

**INDUSTRY** : Air Conditioning  
**PRODUCT** : G250 Vacuum Testing Guns  
**PLANT** : High Rise  
**LOCATION** : Sydney CBD  
**SUMMARY** : Identify leaking tubes on a chiller.

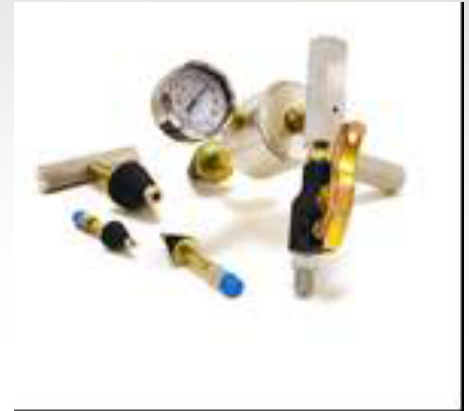
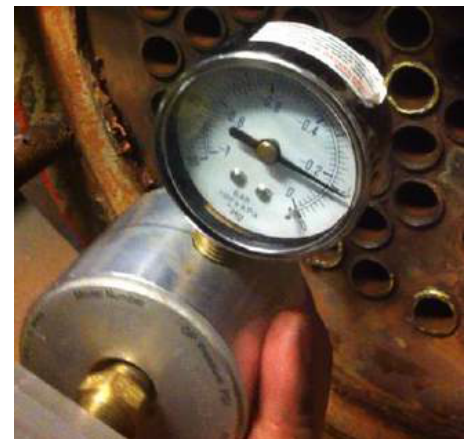
- G250 test guns were pressurized at 4 bar (58.02 psi/ 400kpa).
- A gun is plugged in at one end with plant air and a T-bar vacuum seal at the other side of the tube bundle. Plant air is pressurized to 60 PSI and a vacuum within the tube is created. A fail to create a vacuum would result in a leak being identified.

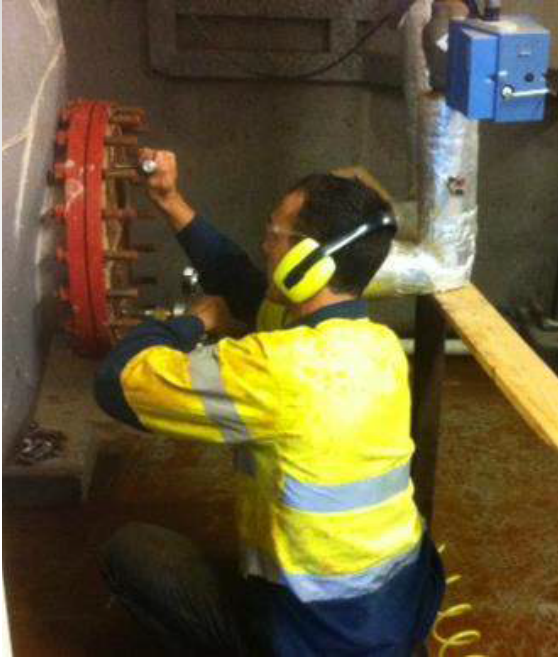
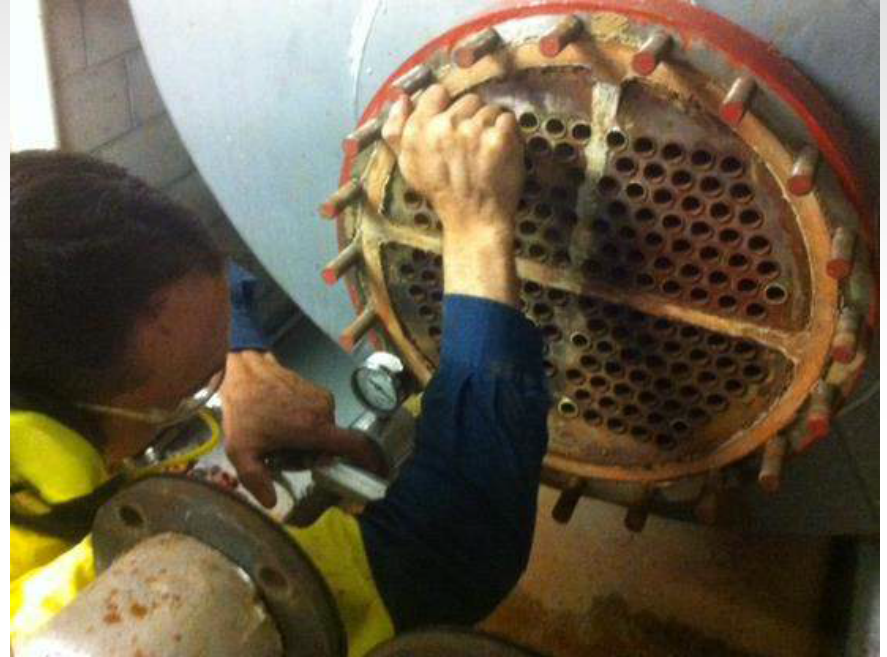
The above images demonstrate the G250 guns detecting leaks in the bundle.

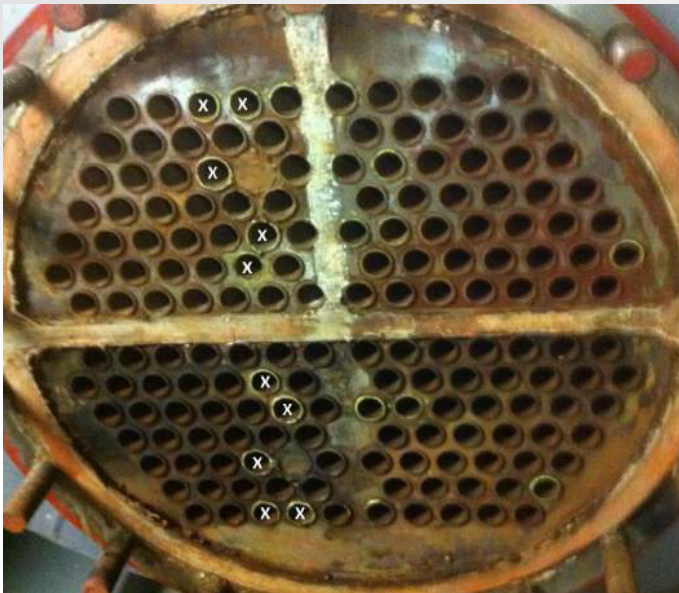
## U-Tube Bundle – Rows and Numbers to be read from Top or Bottom Left

Row 1	Tube # 3 Tube #4	Leaks Present
Row 2		No Leaks
Row 3	Tube # 4 Tube #5 plugged up	Leak Present
Row 4		No Leaks
Row 5	Tube # 6	Leak present
Row 6	Tube # 6	Leak present
Row 7		No Leak
Total Number of leaking Tubes	5

Leaking tubes identified

- Due to unit efficiency decrease, the customer suspected leaking tubes and Imatech Energy Technologies was engaged to perform the required test. The G250 Vacuum guns were used to find how many tubes were leaking.
- 5 leaking tubes were identified on the 17th April 2013, and 1 tube had previously been welded shut.
- Standard practice is to plug 7% of tubes before re-tubing the bundle.
- The above bundle has 86 tubes in total \* 7% = 6 tubes to be plugged.
- Hole leaks identified are 5 and the previous welded plug = 6 plugged tubes.
- As the above results indicate, it is recommended that a more permanent solution is implemented before more leaks occur.
