ArmorPUMP® Unveil High Energy Savings with Vertical Turbine Pumps

A gold mining plant utilising four vertical turbine pumps for pumping freshwater to a processing plant had been experiencing serious operational inefficiencies. The pumps were not performing in line with the client's expectations with regards to service life and performance. The client's main concern lay with the high cost of the pump parts, long lead times (40 weeks) and the lack of OEM maintenance and support for onsite issues. After an onsite assessment, ArmorPUMP® provided them an ideal solution that improved their pump performance, provided high energy savings and amended their regular operational dilemmas.

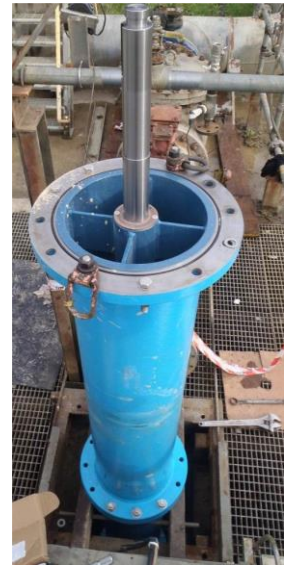
An operational and mechanical assessment of the pumps revealed excessive clearance between the spigot location diameter and the counterbore on the flange ends of the column. This resulted in misalignment, causing uneven wear in the spider bearing bush and shaft that created excessive vibration within the assembly. Consequently, this affected the abrasion and corrosion properties of the medium flowing through the pump.

Further inspection of the parts determined that the product flowing through the pump had a river sand/silt base. This had increased the abrasive operational conditions within the pump leading to accelerated wear on components where no protective coatings had been applied. Other possible factors included the lack of a detailed assembly process with wrongly assembled configurations, poor maintenance practices and a need for regular dredging and cleaning of pump pits.

- Shaft coupling assembly that incorporated split collars with fitted keys
- Coupling – stepped key design
- Sealing arrangement utilising spiral trac and restriction bush design

- Wear rings – flange head design change (bolt on design)
- Column – design change to eliminate misalignment
- Column bearings – material and flange head design change

- Ceramic coating for columns, pump cases, impellers and suction bells
- Discharge housing – ceramic coating of pipe internals with ARC SD4i – advanced polymer/high loading ceramic composite
