CHAIN RELIABILITY - BAKERY

Summary: The chain was contaminated and stiffness was reported in both the chains and carrier trays.

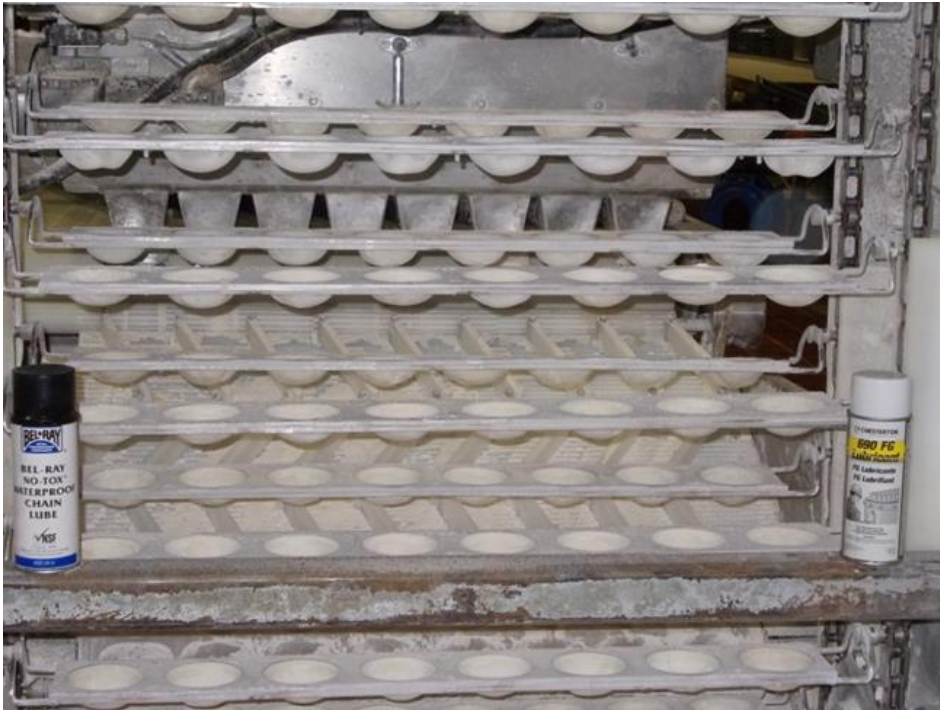
- Chain was contaminated by flour prior to application.
- Customer reported stiffness in both the chains and carrier trays.
- Build up on either side of the trays was preventing free movement and prolonging the proofing of the dough.

- In the bun inter-proofing area there was one bay with 2 x 30m lengths of chain, 60m in total. The chains had been lubricated with Belray No-Tox®.
- Chains were lubricated and cleaned weekly with air driven technology.
- Retensioning of the chains was required once a month on average.

- After initial application of Chesterton® 690 FG across 60m of chains, results were almost immediate.
- Chains appeared cleaner and allowed free movement of the carrier trays.
- No stretch in the chain is evident to date.
