**FERTILISER
SCRUBBER
FANS**

Product: Chesterton® ARC SD4i

Plant: Granulating Plant

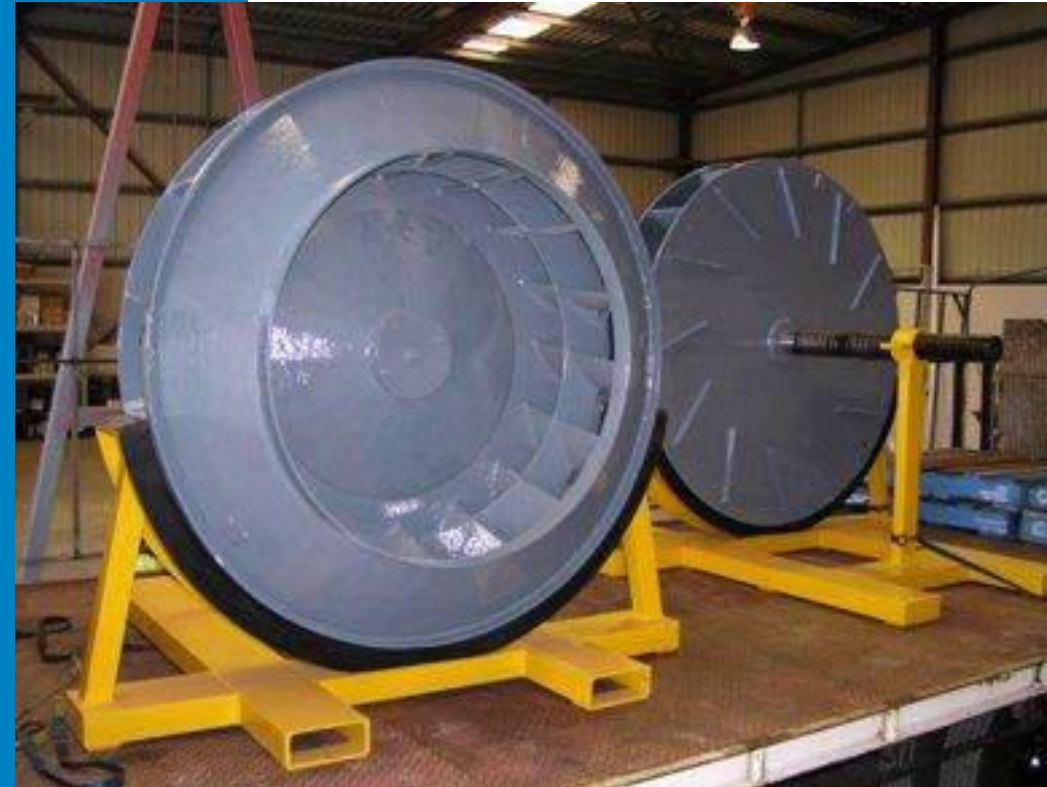
Summary: Wet fertiliser sticks to the fans, causing them to become imbalanced. This results in the equipment constantly needing to be shut down and the fans requiring cleaning by abrasive blasting.

- Build up of fertiliser causing fans to vibrate and become imbalanced.
- This required a shutdown every two weeks for the fans to be sandblasted to remove the build up. Approximately one tonne of garnet was used in this process.

- The fans were lined with Chesterton® ARC SD4i ceramic composite coating, providing a high gloss finish with superior abrasion resistance.
- The fans now remain unaffected for a period of approximately 4 months and can be cleaned using low pressure water only.
- Based on the success of ARC SD4i the customer decided to trial various other, competitor lining systems.
- The customer found that none, apart from Imatech's coating, managed to last very long due to the abrasive nature of the fertiliser.

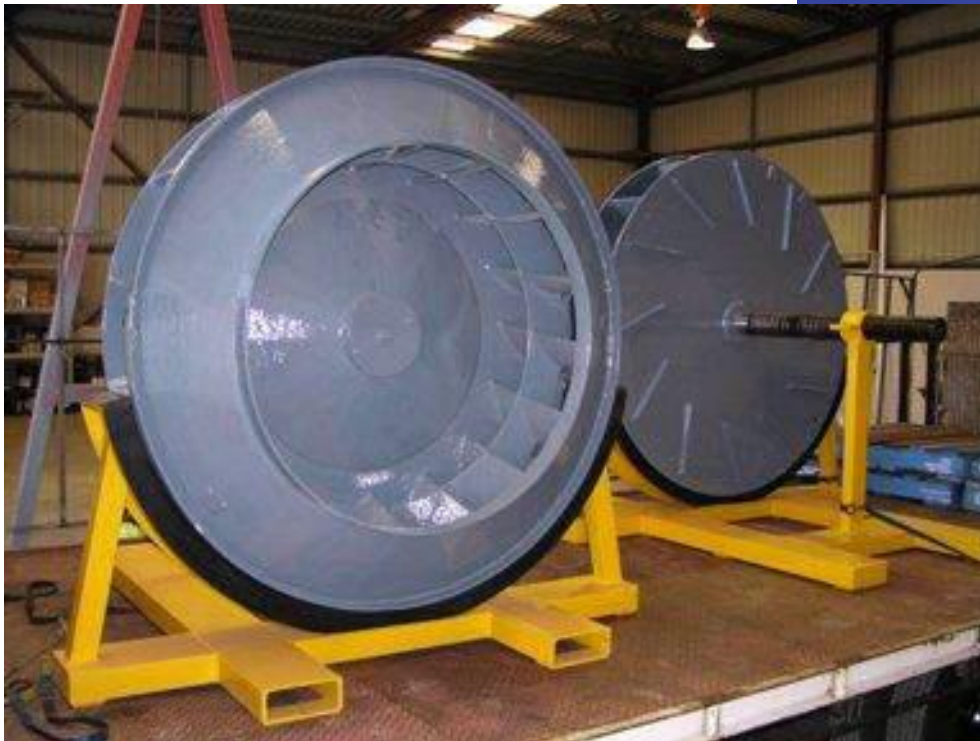
RESULTS

The plant now specifies that all scrubber fans are lined with Imatech composites.
