**LEACH TANK
REPAIR - GOLD
MINING**

Plant: Leach Tank

Location: Cracow, QLD, Australia.

Summary: Imatech received an emergency call to repair a Leach Tank.

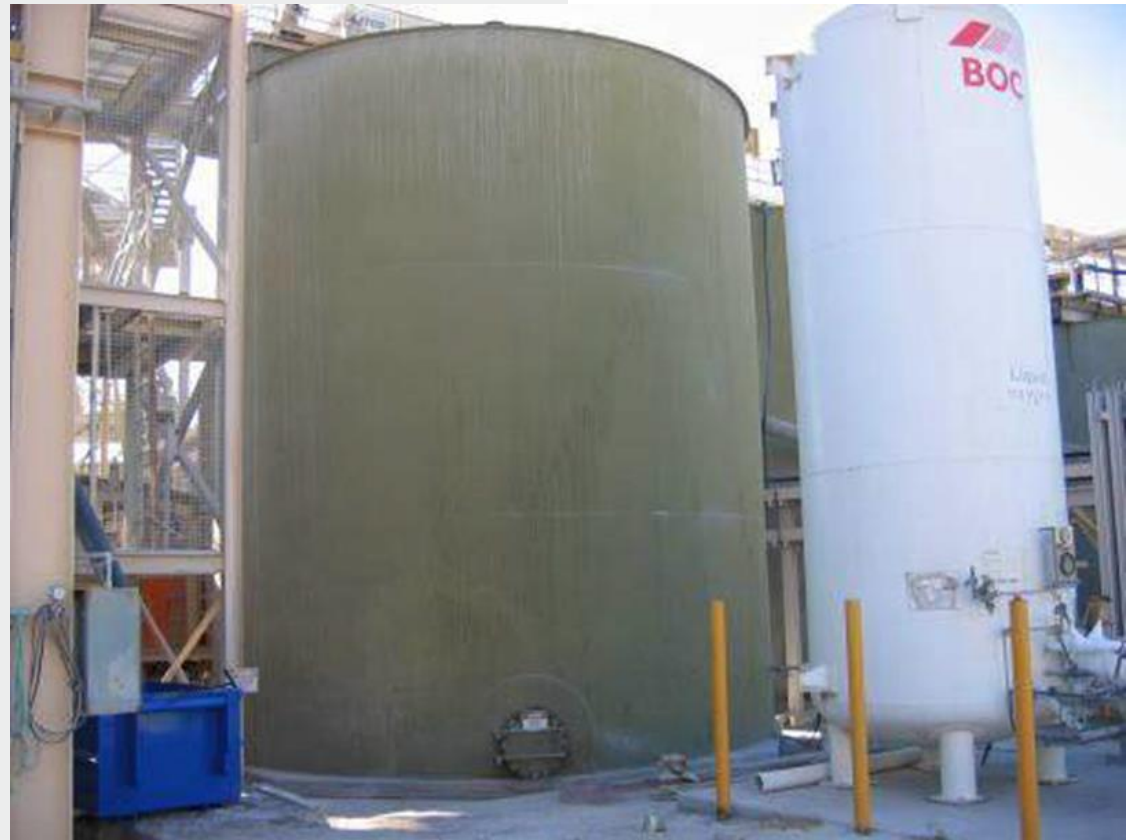
The tank had holed out, which meant the plant was only running at 80% capacity. Imatech mobilised and started repairs 48 hours from receiving the call.

The tank floor had holed out the entire way around the base, due to corrosion. This caused major problems with chemical substances leaking from the tank; leading to removal from service.

- The entire base and 1m up the sidewalls was abrasive blasted.
- A SCAT test was carried out revealing high levels of salt in steel. This was treated, bringing it down to acceptable levels to ensure longevity of coating.

Surface was then re-blasted to achieve a 75µm to 120µm profile and Chesterton® ARC 858 ceramic regrading compound applied to repair major holes.

- A blend of ARC BX2 (trowelable) and 30% ARC SD4i (sprayable) was mixed to produce an abrasive and chemical resistant slurry.
- This was easily trowelled around the entire 27m perimeter of the tank repairing and protecting the heavily pitted surface and providing a smooth surface to spray apply the top coating.

A two-colour ceramic composite system was then spray applied to the entire internals of the tank.

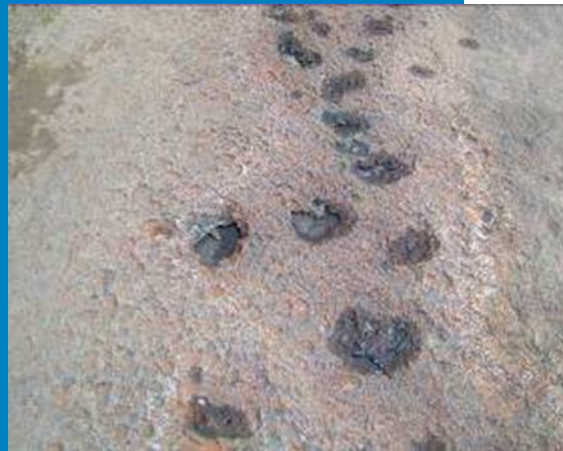
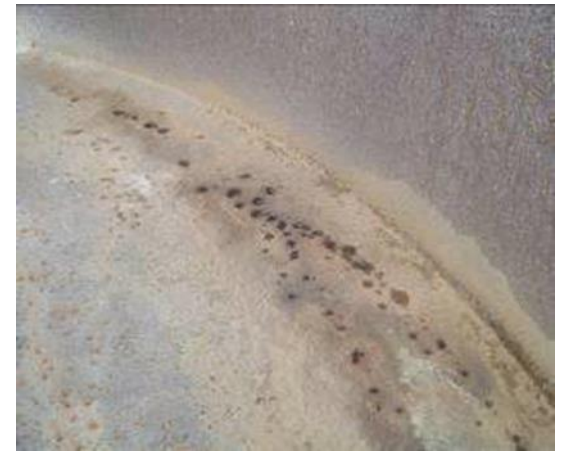
- Cyanide (240ppm)
- -53 μ slurry
- 10.5+ PH
- Oxygen added through sparges

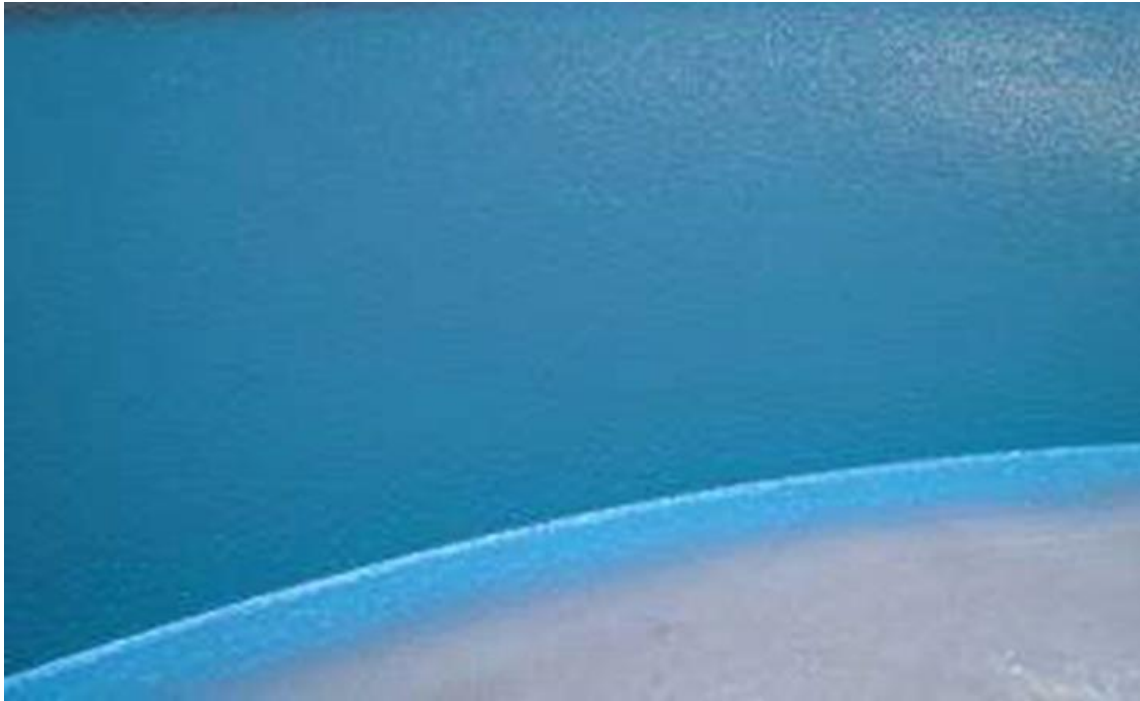
As Imatech had effectively started repairing the tank 48 hours from receiving the call, the client was able to get back to service and run at full capacity within 3 days. Conducting the repair on time saved the client significant downtime and money.
