MINE BACKFILL - PASTEFILL CANADA

SUMMARY

Product: ArmorPIPE™ 7500

Plant: Paste Backfill Plant

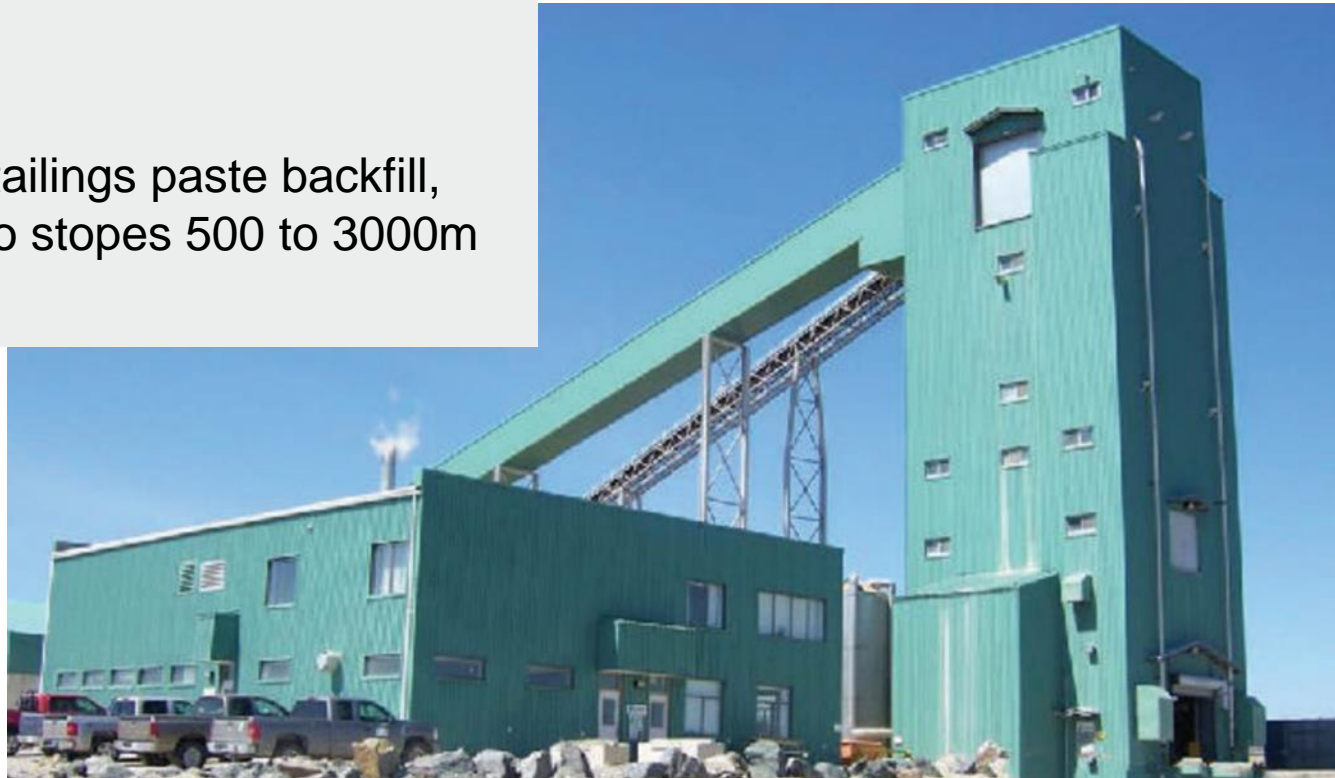
API X52 schedule 140 pipes holing in 1.2 million tonnes of placed fill.
The additional complications of thinned casings peeling internally were
resulting in costly blockages.

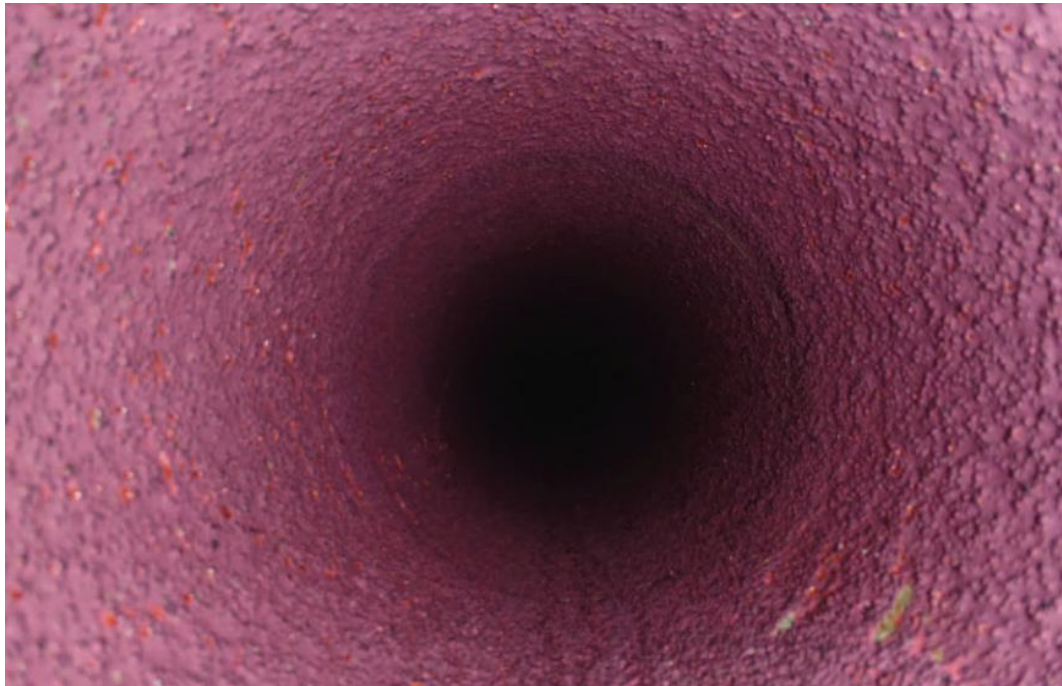
7500 Series Paste Fill Lined Pipe

ArmorPIPE™ 7500 Series pipe was recommended as the most suitable material based on the process conditions and expected mine life.

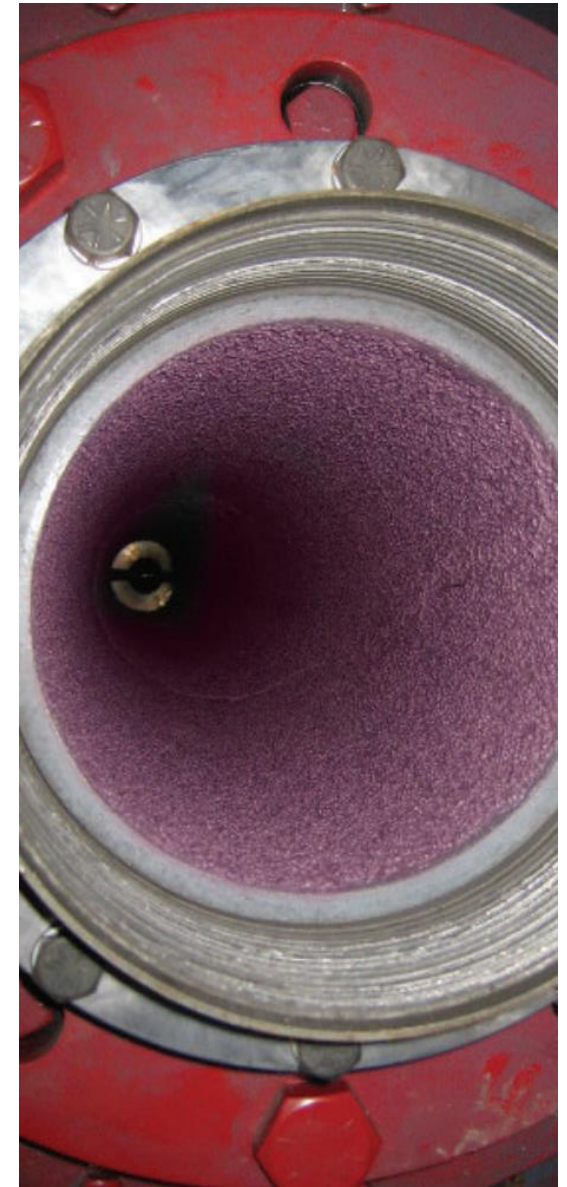
In service after 4 million tonnes following replacement- approx. 80% of lining remains.

The ArmorPIPE™ 7500 Series pipe is currently still in service after 4 million tonnes with approximately 80% of the lining remaining.
