**MINING RESEARCH  
FACILITY-  
CHEMICAL  
PROCESS AREA**

**Summary:** Degraded coatings and concrete removed and renewed using ARC chemical resistant coatings in chemical storage areas, production areas, drains and sumps.

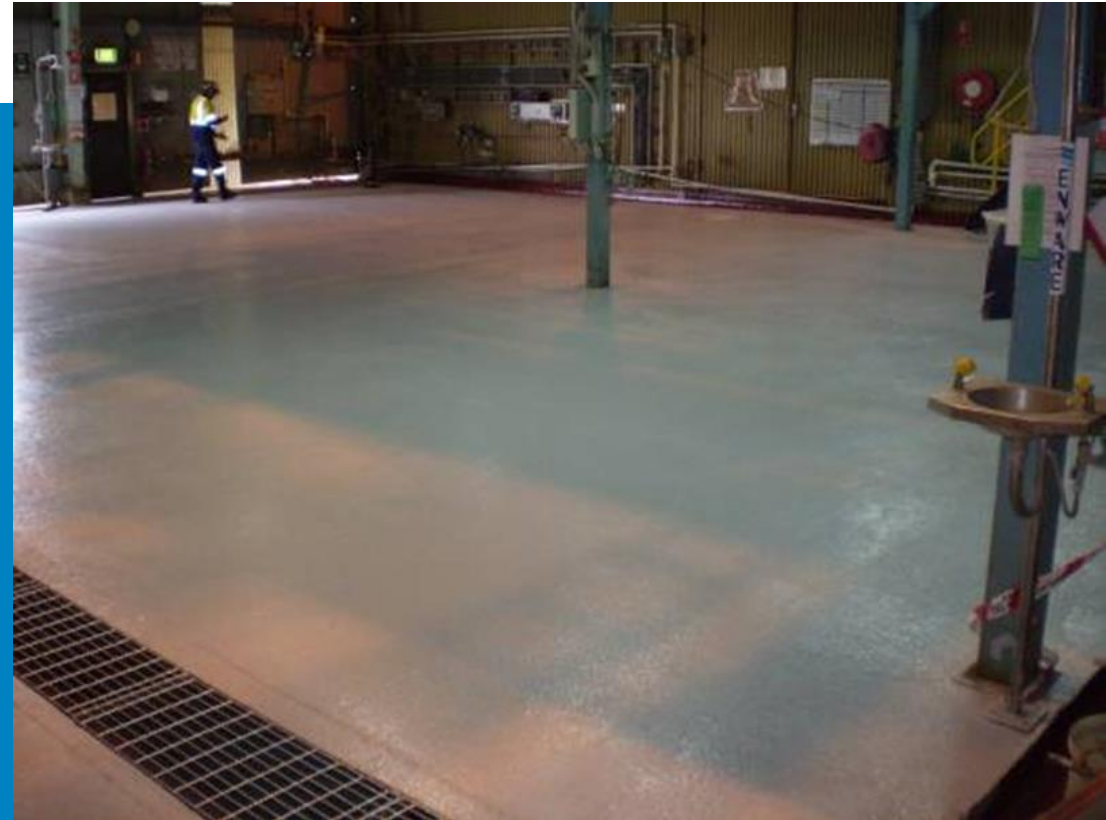
- Previous coatings, grouts and sealants had failed leaving the floor.
- Drains, sumps and expansion joints exposed to various chemicals including sulphuric acid, caustic and other industrial chemicals.

- Previous coatings, sealants and damaged concrete were removed using grinding, abrasive blasting and water blasting.
- Heavily degraded areas, in the drains, sumps and around the expansion joints were rebuilt using ARC 988 quartz composite coating.
- Chesterton® ARC CS2 and Chesterton® ARC CS4 were used to protect the floors, drains and sumps.
- Floor coatings incorporated Imatech's non-slip surface finish.
- All expansion joints were resealed using Emerseal CR.

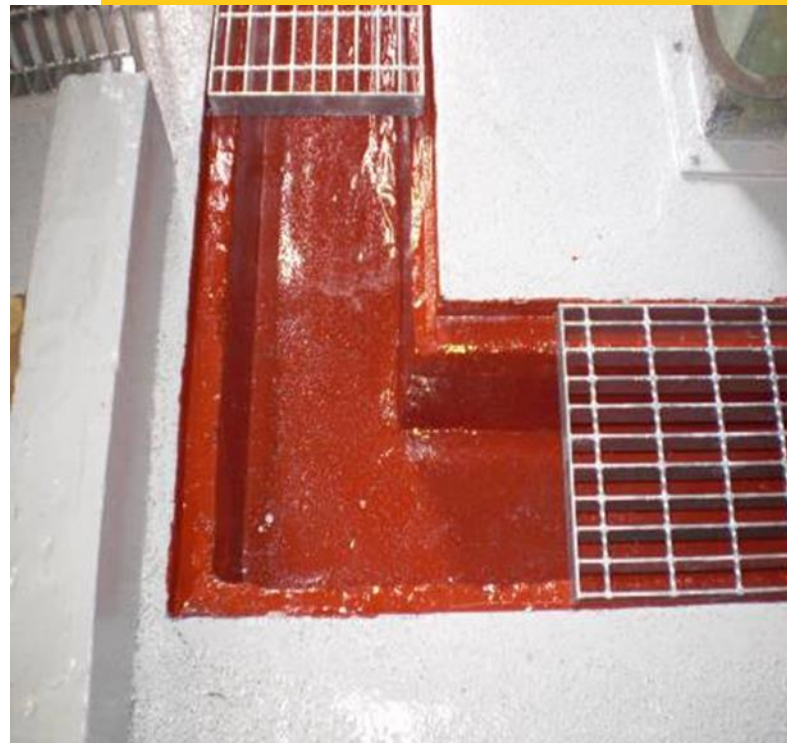
Final Coat ARC CS2 and ARC CS4

After 18+ months, the coatings are in excellent condition. There is no delamination or chemical attack of the coatings under constant foot traffic, forklift traffic and regular exposure to high concentrations of acids and other chemical solutions.
