# SULPHURIC ACID RECEIVAL BUND

**Plant:** Sulfuric Acid Receival Bund

**Location:** Eraring, NSW Australia

**Summary:** Existing protective liner failure in a number of areas enabled direct exposure to the concrete surface allowing chemical corrosion. Pooling areas, drain grate and sump internals also suffered severe corrosion.

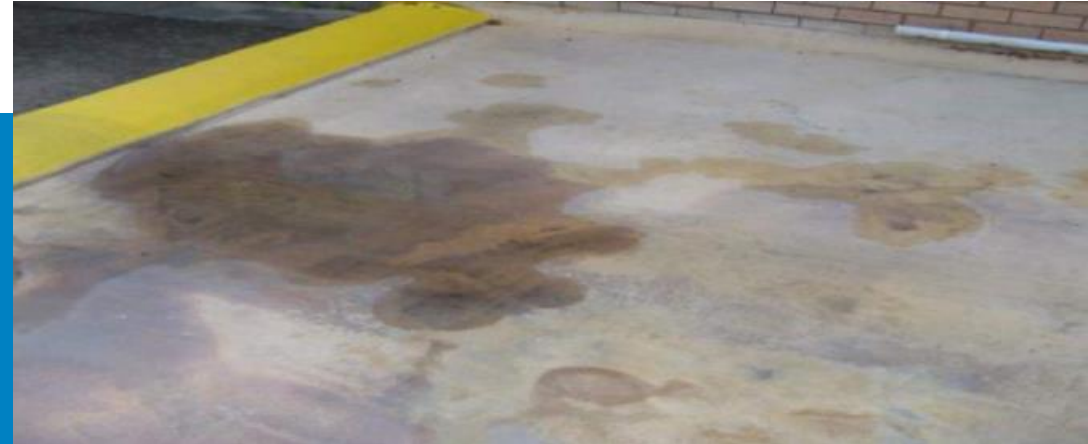
Corrosion of the pooling areas is quite evident.

Pooling areas were re-graded using Chesterton® ARC988 ceramic reinforced composite.

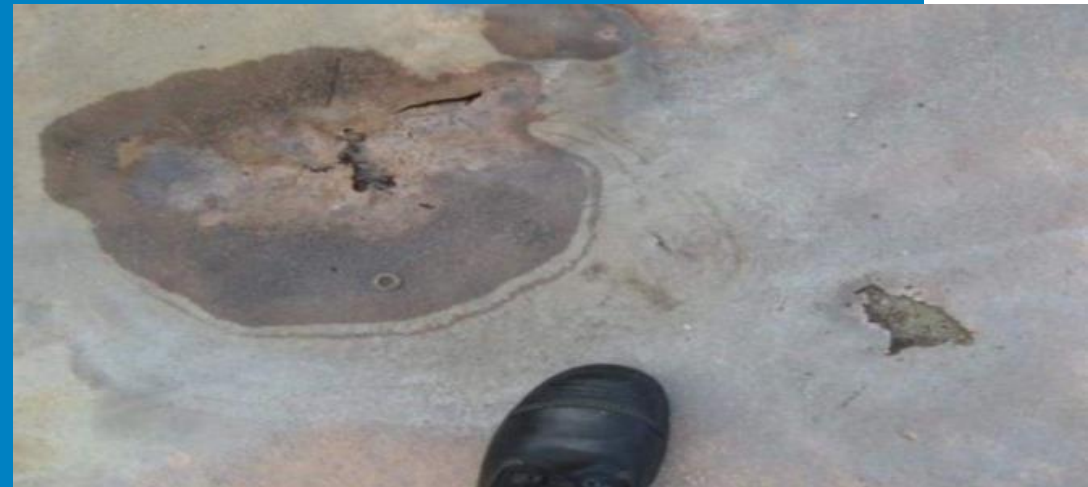
Liner failure exposing concrete surface.

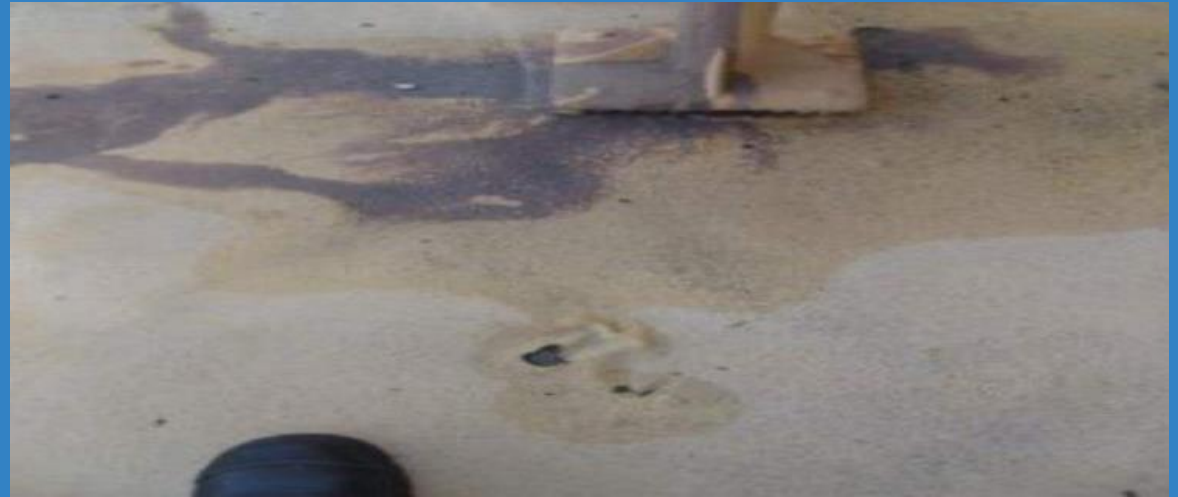
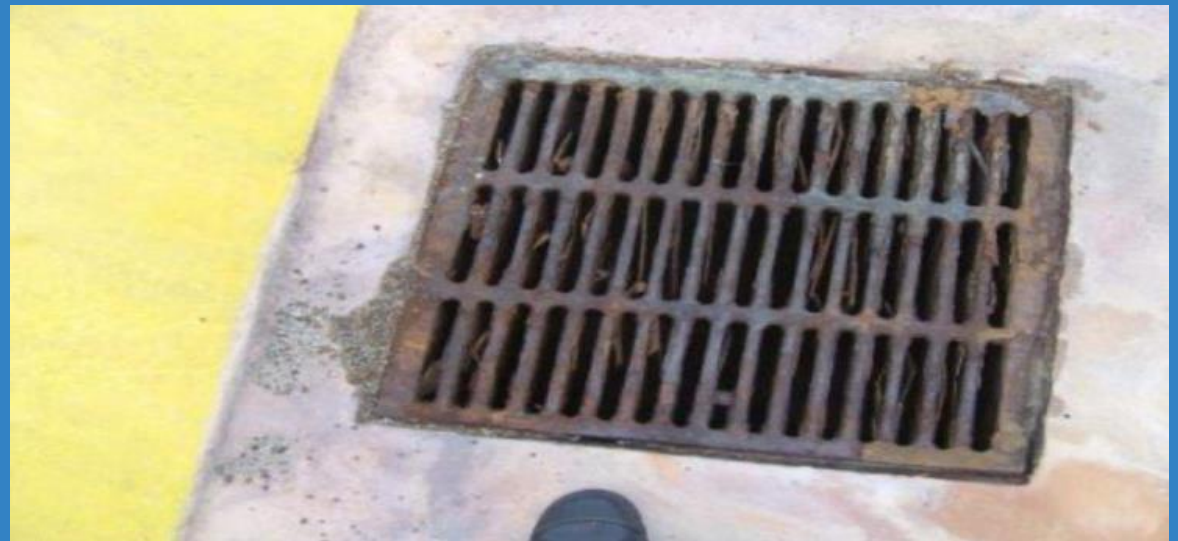
Due to acid spillages at the connection points, the steel coated supports were badly corroded with severe chemical corrosion evident on the drain grate and sump internals.
