# **WATER BOX RE-BUILD & COATING**

**Summary:** Re-build and coat Chiller  
End caps using Chesterton® ARC Sd4i,  
Ceramic Composite coating.

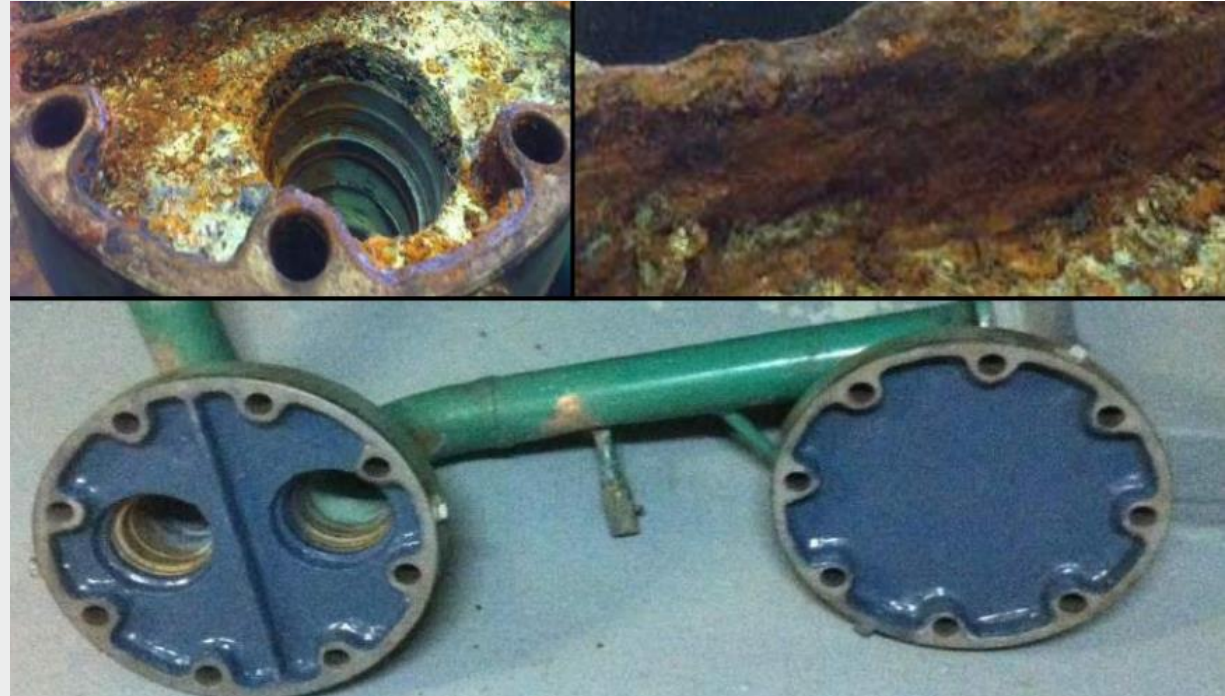
End Caps for one of the chillers was severely corroded and the divider plate on the inlet and outlet side sustained significant wall loss.

- Preparation to upgrade abrasive blasting to Class 2.5 – 3 using Imatech blast system.
- Build up severely corroded areas using Chesterton® ARC 858.
- Chesterton® ARC Sd4i to be applied in 2 coats, blue then grey, to a total average DFT of 600 microns.

- Divider plate built up with Chesterton® ARC 858 flush with the sealing flange.
- Chesterton® ARC Sd4i was then applied in two coats to protect the surface from corrosion.
- High gloss finish reduces drag and increases efficiency.
